Heritage Impact Assessment for Centennial Campus Project, The University of Hong Kong

prepared in accordance with
DEVB Technical Circular (Works) No. 11/2007,
the Guidelines for Built Heritage Impact Assessment (BHIA)
(as at 16 May 2008)

Revision	4
Issue status	Issued
Prepared by	Ivan Ho of The Team Consultant
Approved by	Robert Lam of Wong & Ouyang (HK) Limited
Date	2 nd December, 2008
Total number of pages in main report	30
Total number of appendices enclosed	6

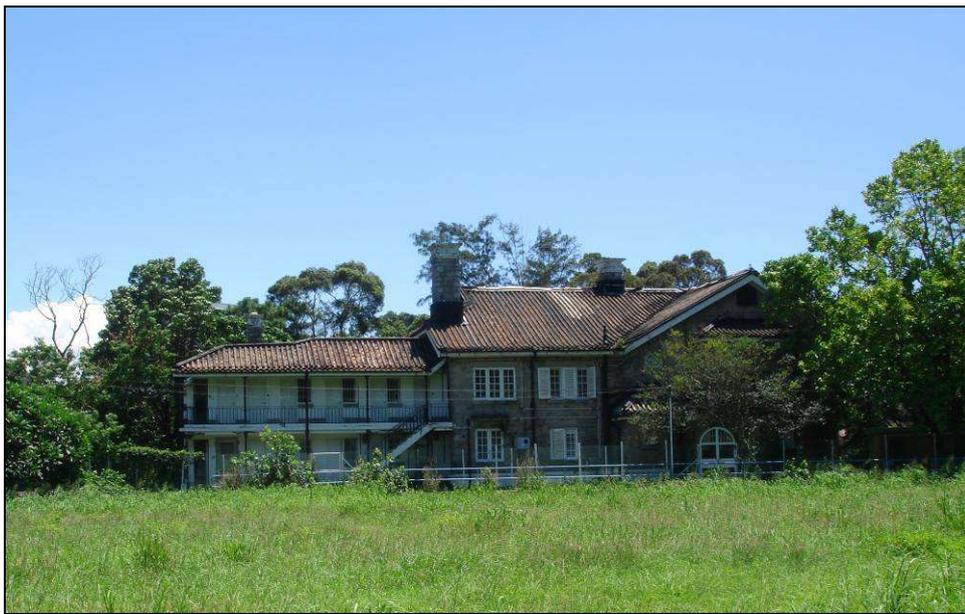
Plate 1 – Elliot Pumping Station and Filters, Senior Staff Quarters
(Senior Staff Quarters)

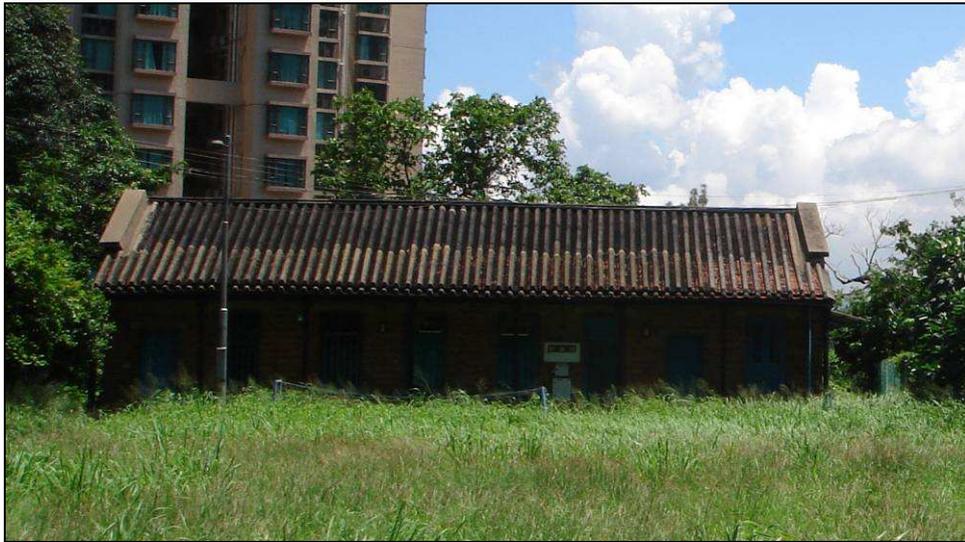
Plate 2 – Elliot Pumping Station and Filters, Workmen's Quarters
(Workmen's Quarters)

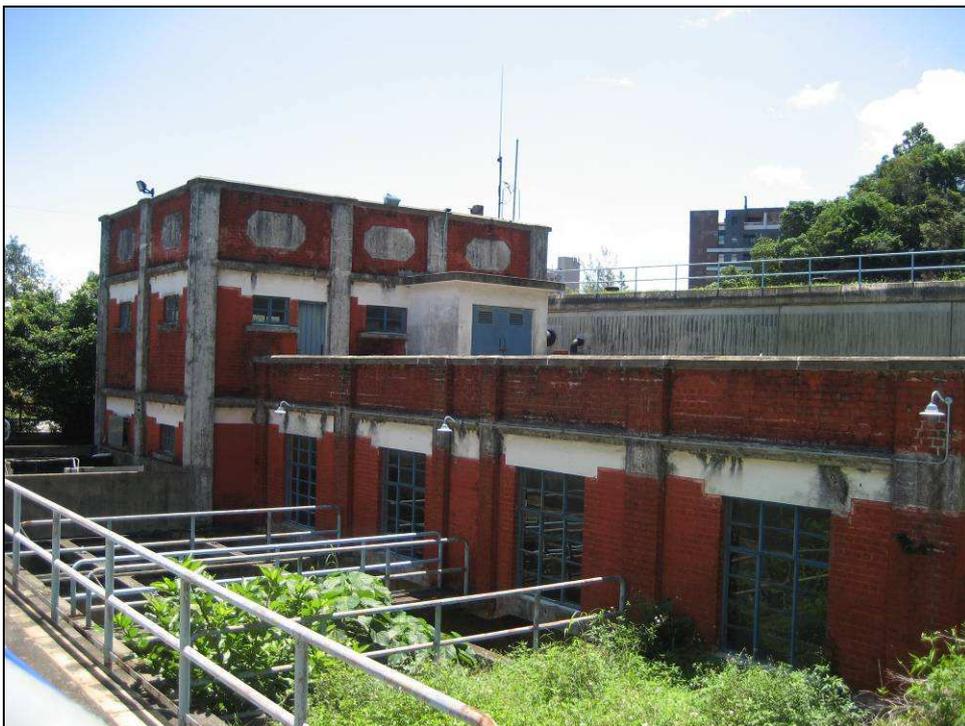
Plate 3 – Elliot Pumping Station and Filters, Treatment Works Building
(Treatment Works Building)

The Treatment Works Building is a utilitarian structure reflecting one stage in the pre-war second world war development of filtration processes for the public water supply. It has some value as a representative example of those technical processes, particularly in the equipment which remains in situ. It replaced the original filtration system set up in 1914 – 5.”

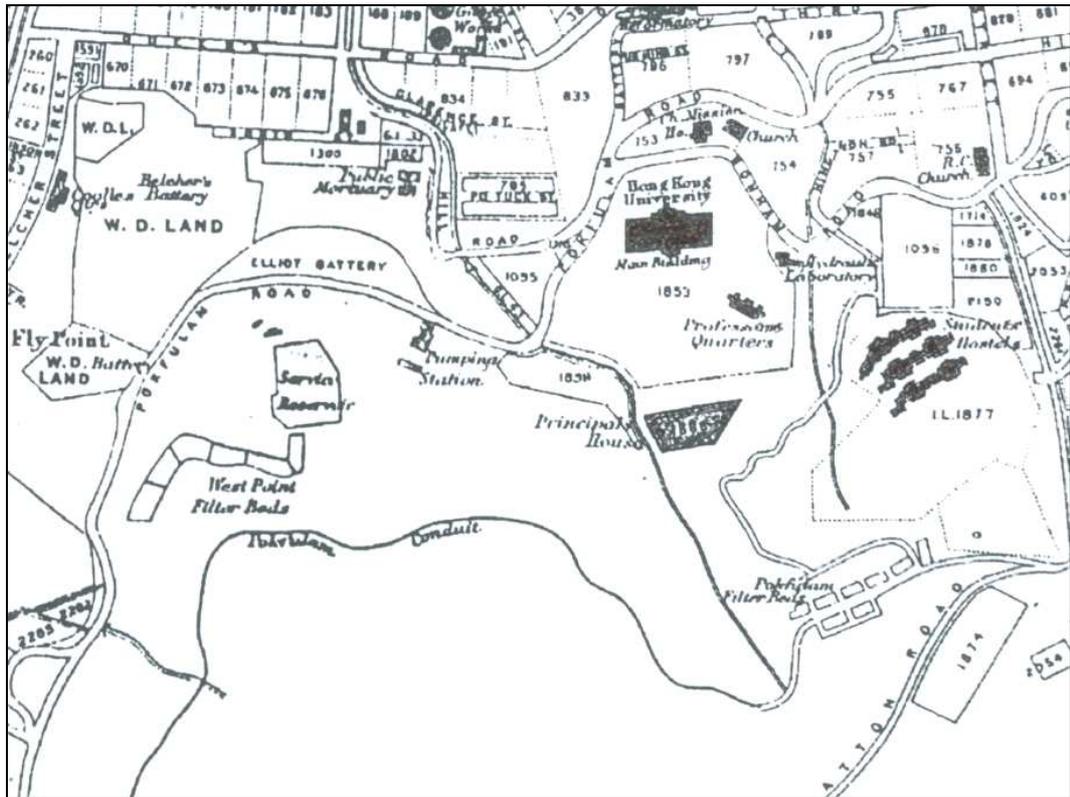
Extract from 1923 survey of Western District

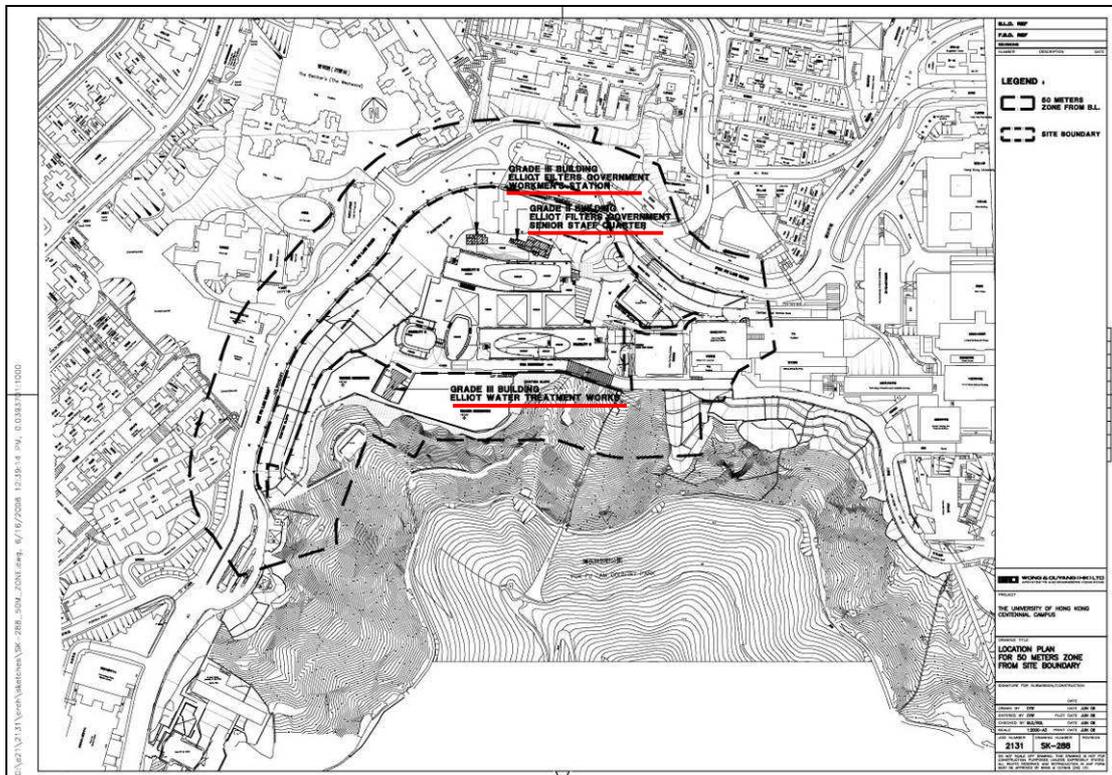
B5.2 A master layout plan showing the three historic buildings is shown below.

Plate 4 – Site plan of the Centennial Campus
with the three historic buildings high-lighted

A1.2 These three historic buildings will be adapted and integrated into the new Centennial Campus. An A3 size site plan of the Centennial Campus Project with the locations of the three historic buildings is enclosed as Appendix 1 for reference.

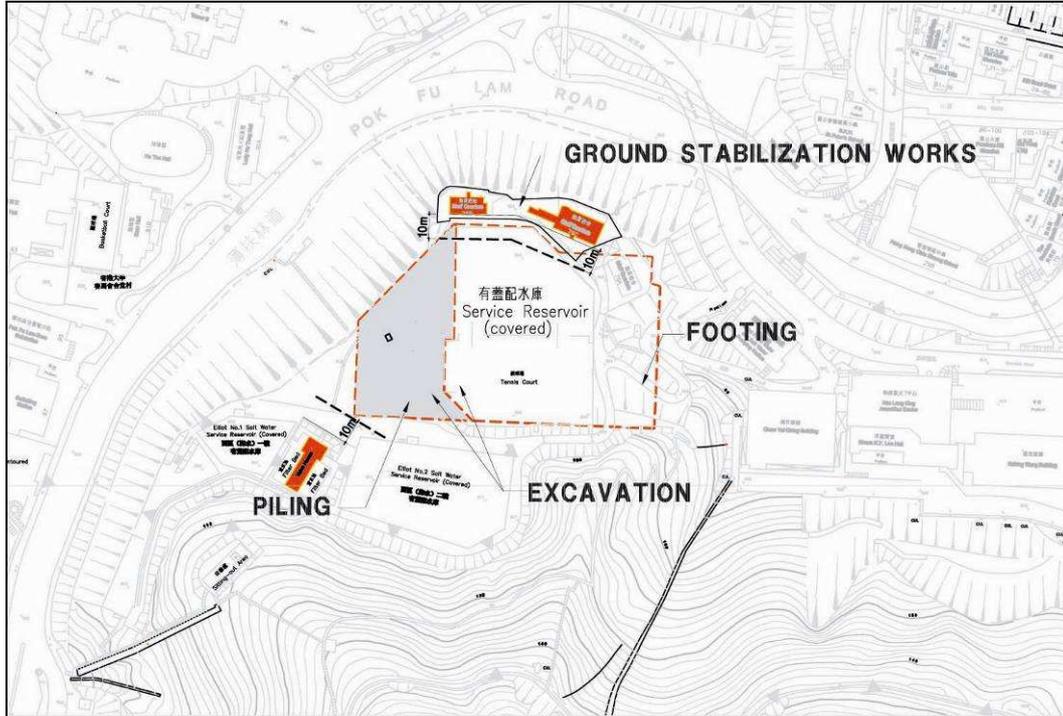
Plate 5 – Ground stabilization works and foundation works

- (i) **Ground Stabilization Works**
Bearing in mind the importance to avoid disturbance and settlement of the important heritage buildings, protective measures in the form of Ground Stabilization Works will be carried out to the Senior Staff Quarters and Workmen's Quarters prior to the commencement of demolition of the existing reservoir, piling, excavation and soil nail works. The proposed works consist of a row of grouted piles around the Quarters which forms a separation barrier and protects them from disturbance from future construction works. Cement grout will then be applied around and under the Quarters to stabilize the soil base. Only non-percussive plants will be used and grouting will be carried out under low pressure not exceeding the original stress state of the soil. The proposal has been approved by Buildings Department and Geo-technical Engineering Office.

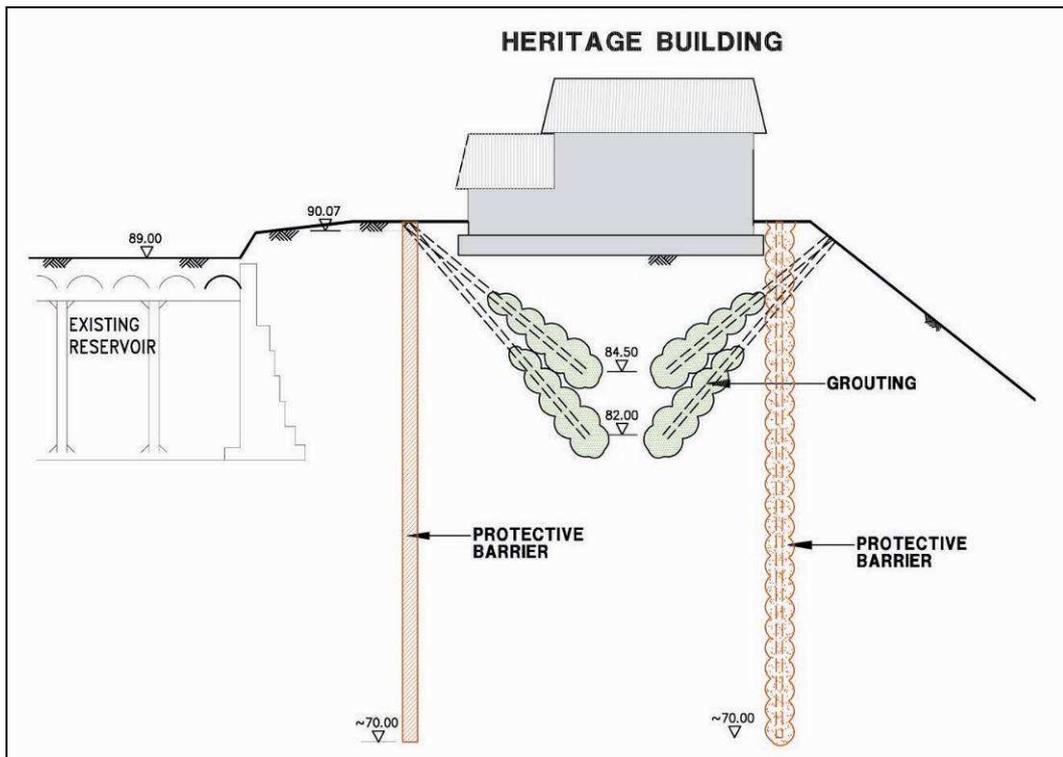
Plate 6 – Ground Stabilization Works – Schematic Section

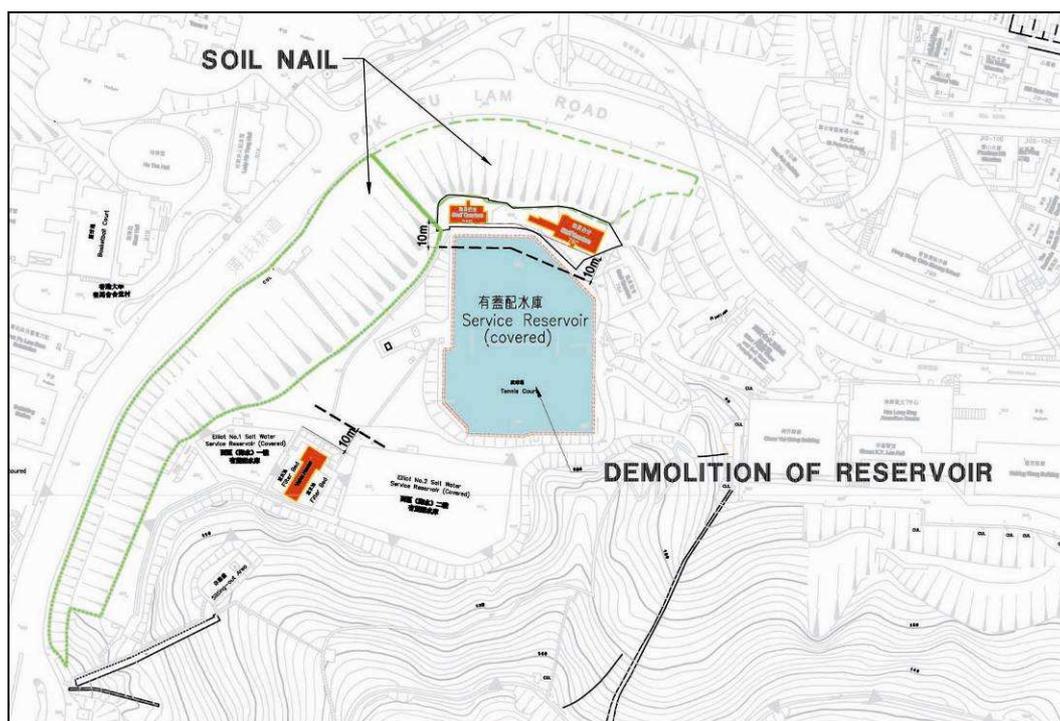
(ii) Demolition of adjacent existing covered service (fresh water) reservoir – Prior to demolition, the existing covered service (fresh water) reservoir wall will be shored up with steel struts as a precautionary measure. The first bay of the reservoir roof adjacent to both Quarters will be taken down first so that the remaining roof structure is separated from the historic buildings and the disturbance minimized. Demolition works will be carried out using non-percussive methods such as saw-cutting and hydraulic crusher. The vibration induced will be minimal and the effect of demolition of the two existing fresh water reservoirs is considered insignificant in engineering terms.

Plate 7 – Demolition of existing covered service (fresh water) reservoir
and soil nail works

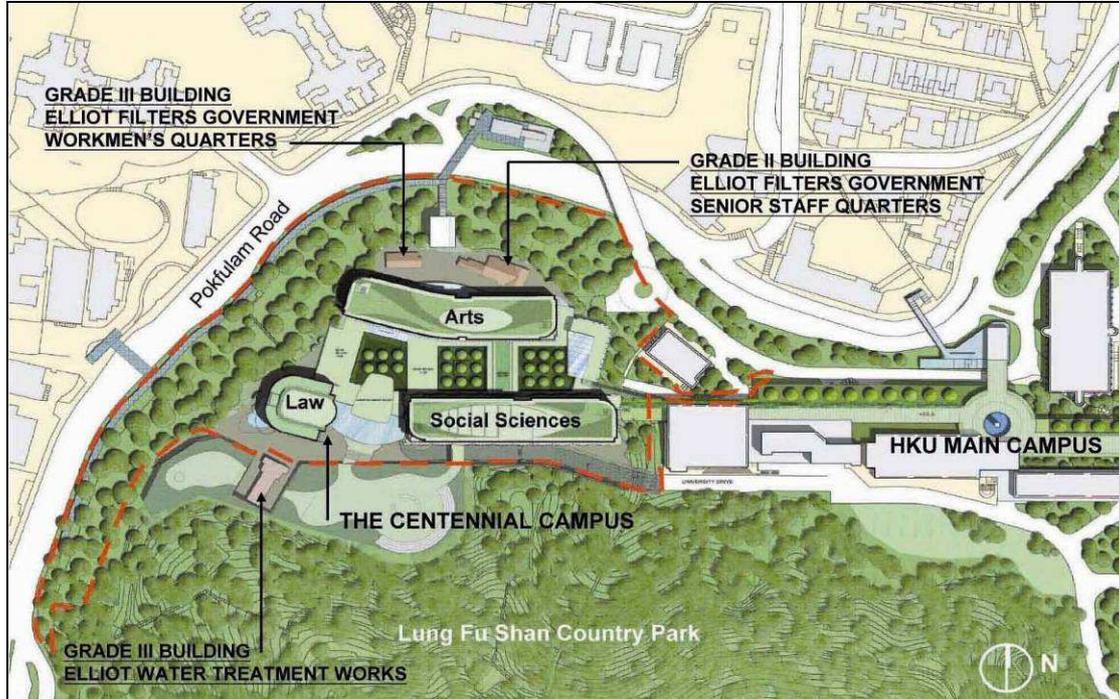
Plate 8 – Location plan

C3.1 Plan and section of the Centennial Campus Project –
Plan and section of the Centennial Campus Project are shown below.

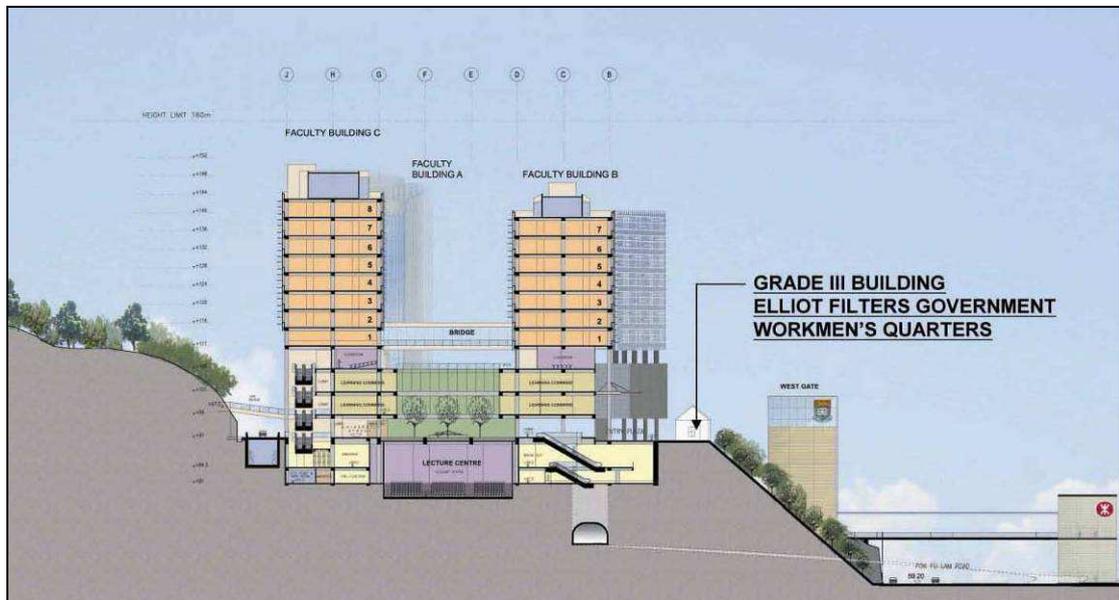
Plate 9 – Section

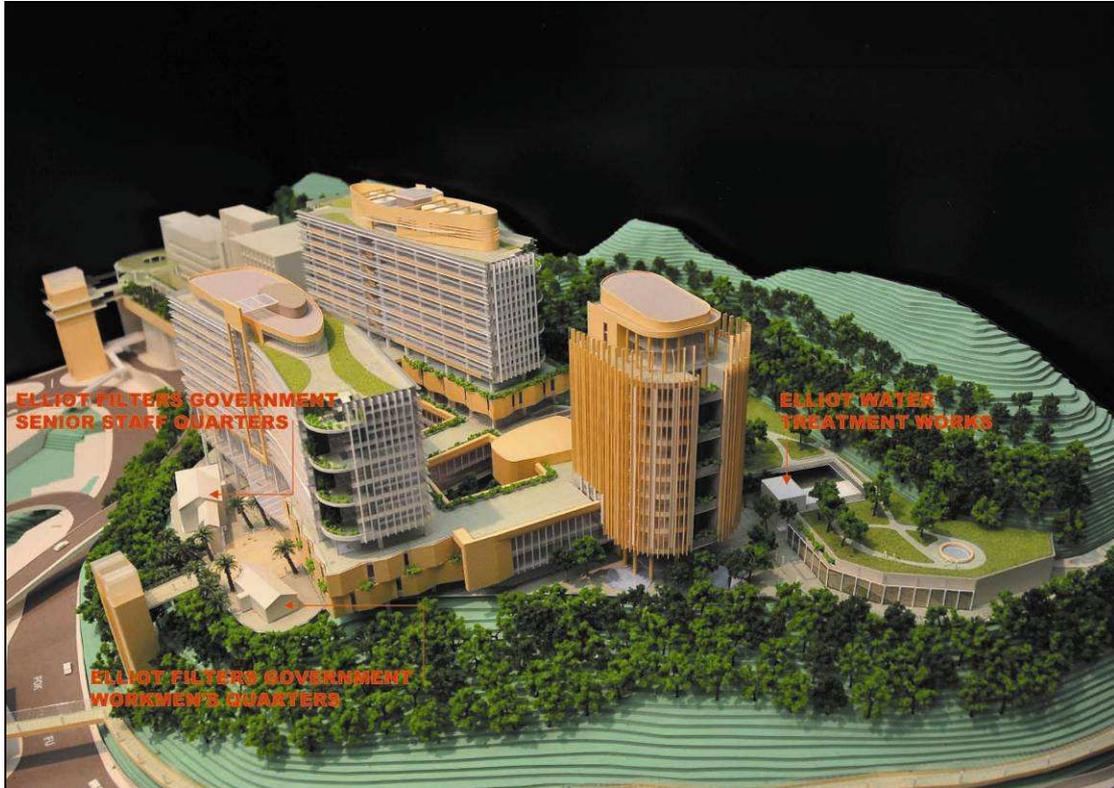
Plate 10 – Aerial view of the model of the Centennial Campus model

C3.2 Photo of the model of Centennial Campus Project –
Aerial photos of the model and view of the entry plaza of the Centennial
Campus are shown below.

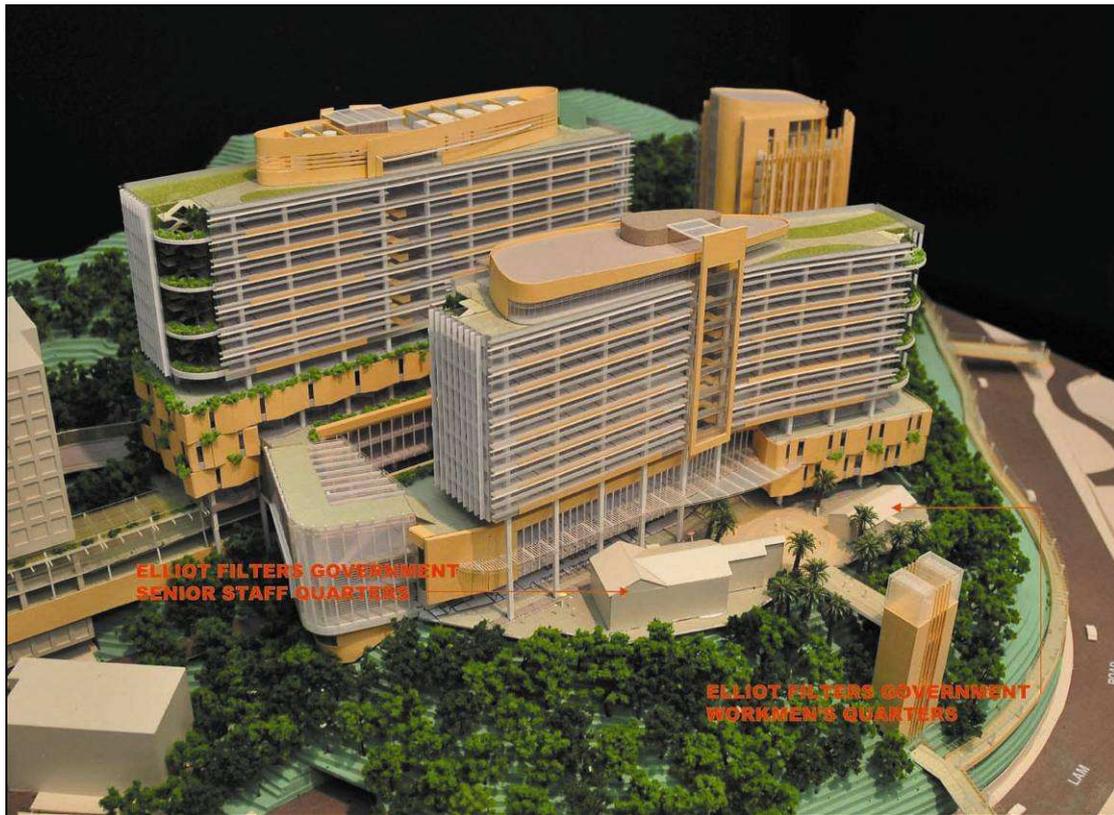
Plate 11 – Aerial view of the model of the Centennial Campus model

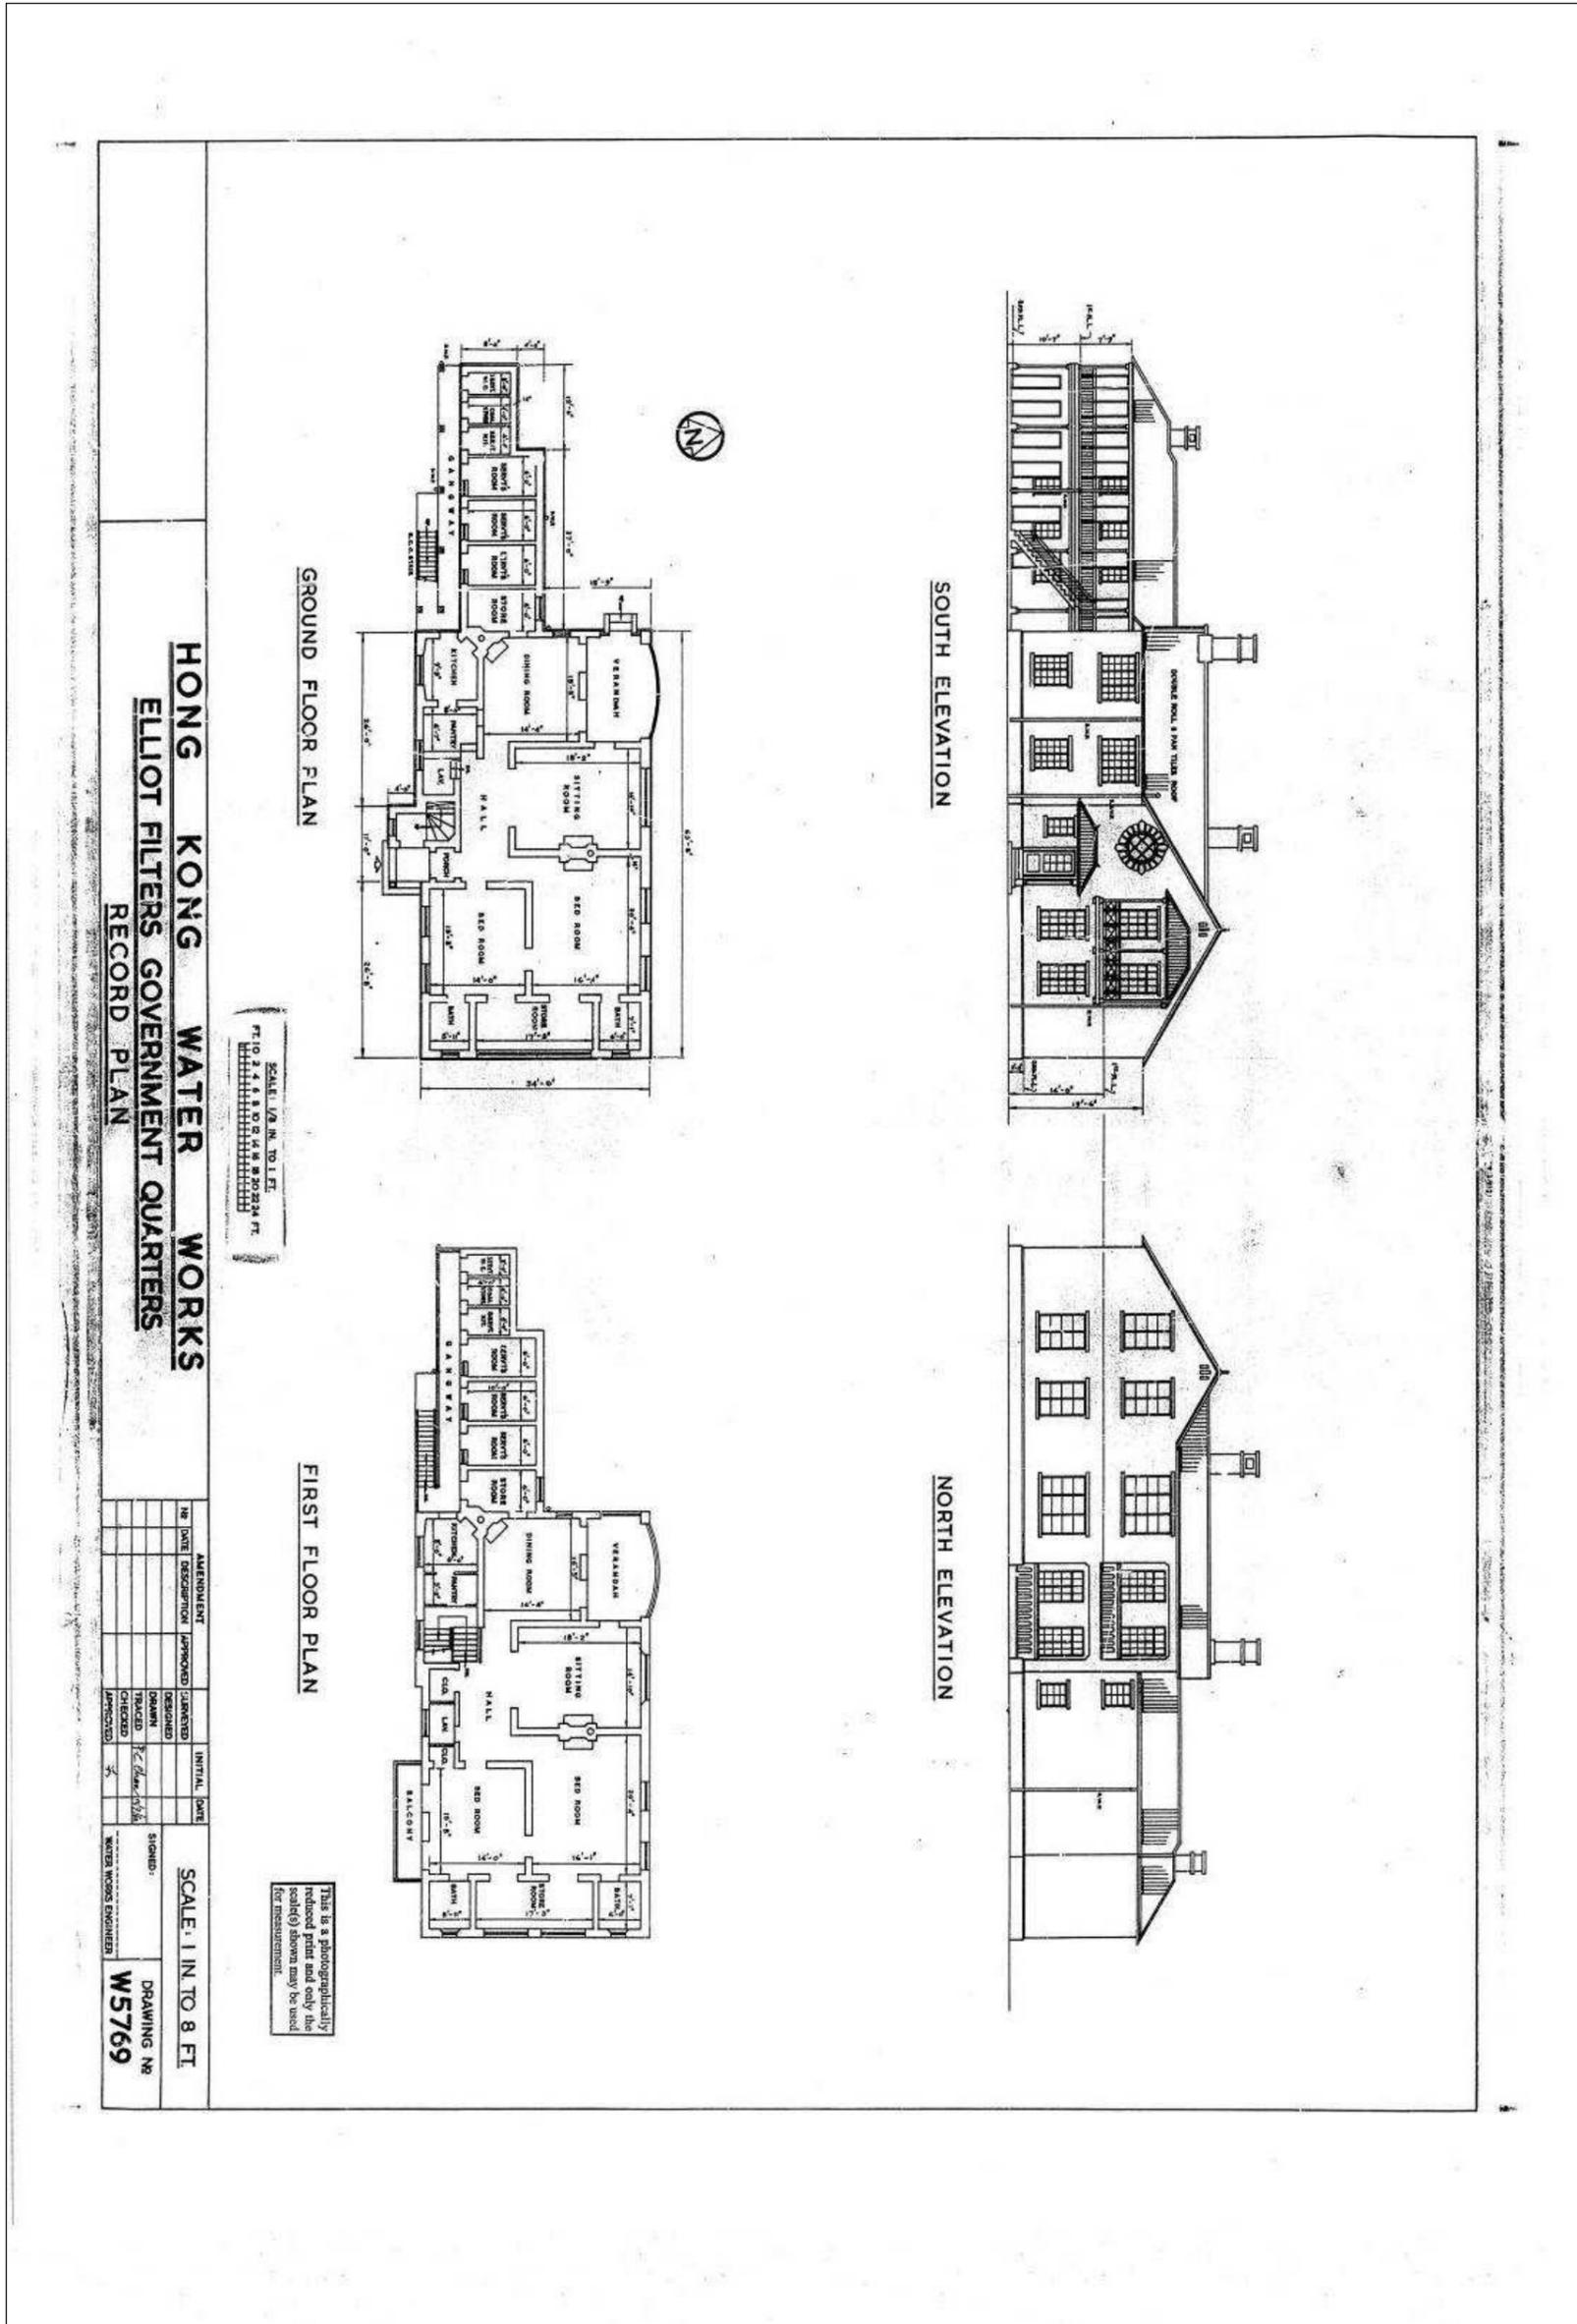
**HONG KONG WATER WORKS
ELLIOT FILTERS GOVERNMENT QUARTERS
RECORD PLAN**

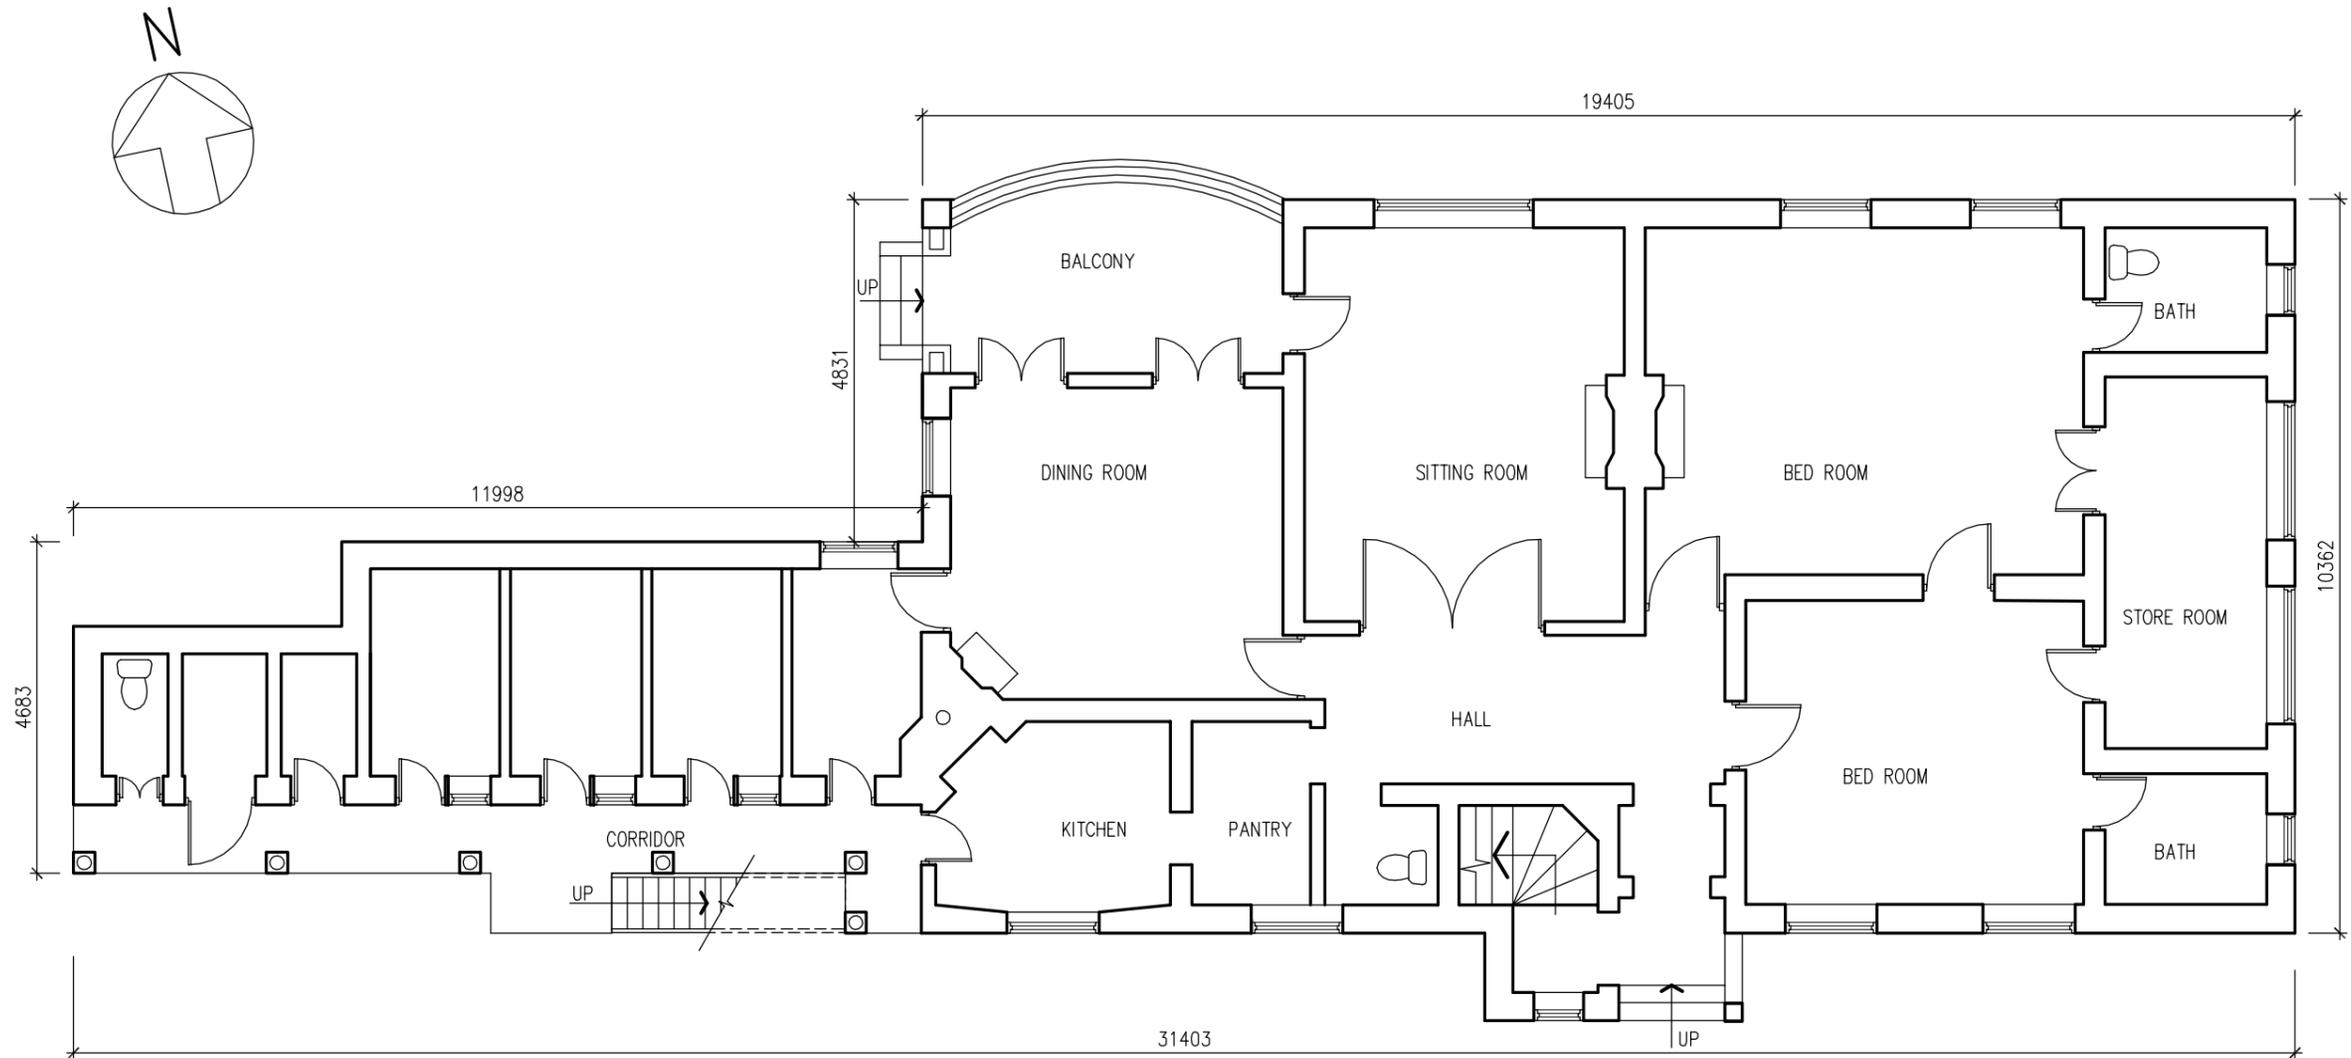
Scale	1 : 100 (A3 size drawing)
Drawing No.	SSQ-01
Date	21 September,2008

**Elliot Pumping Station and Filters
Senior Staff Quarters
Ground Floor Plan**

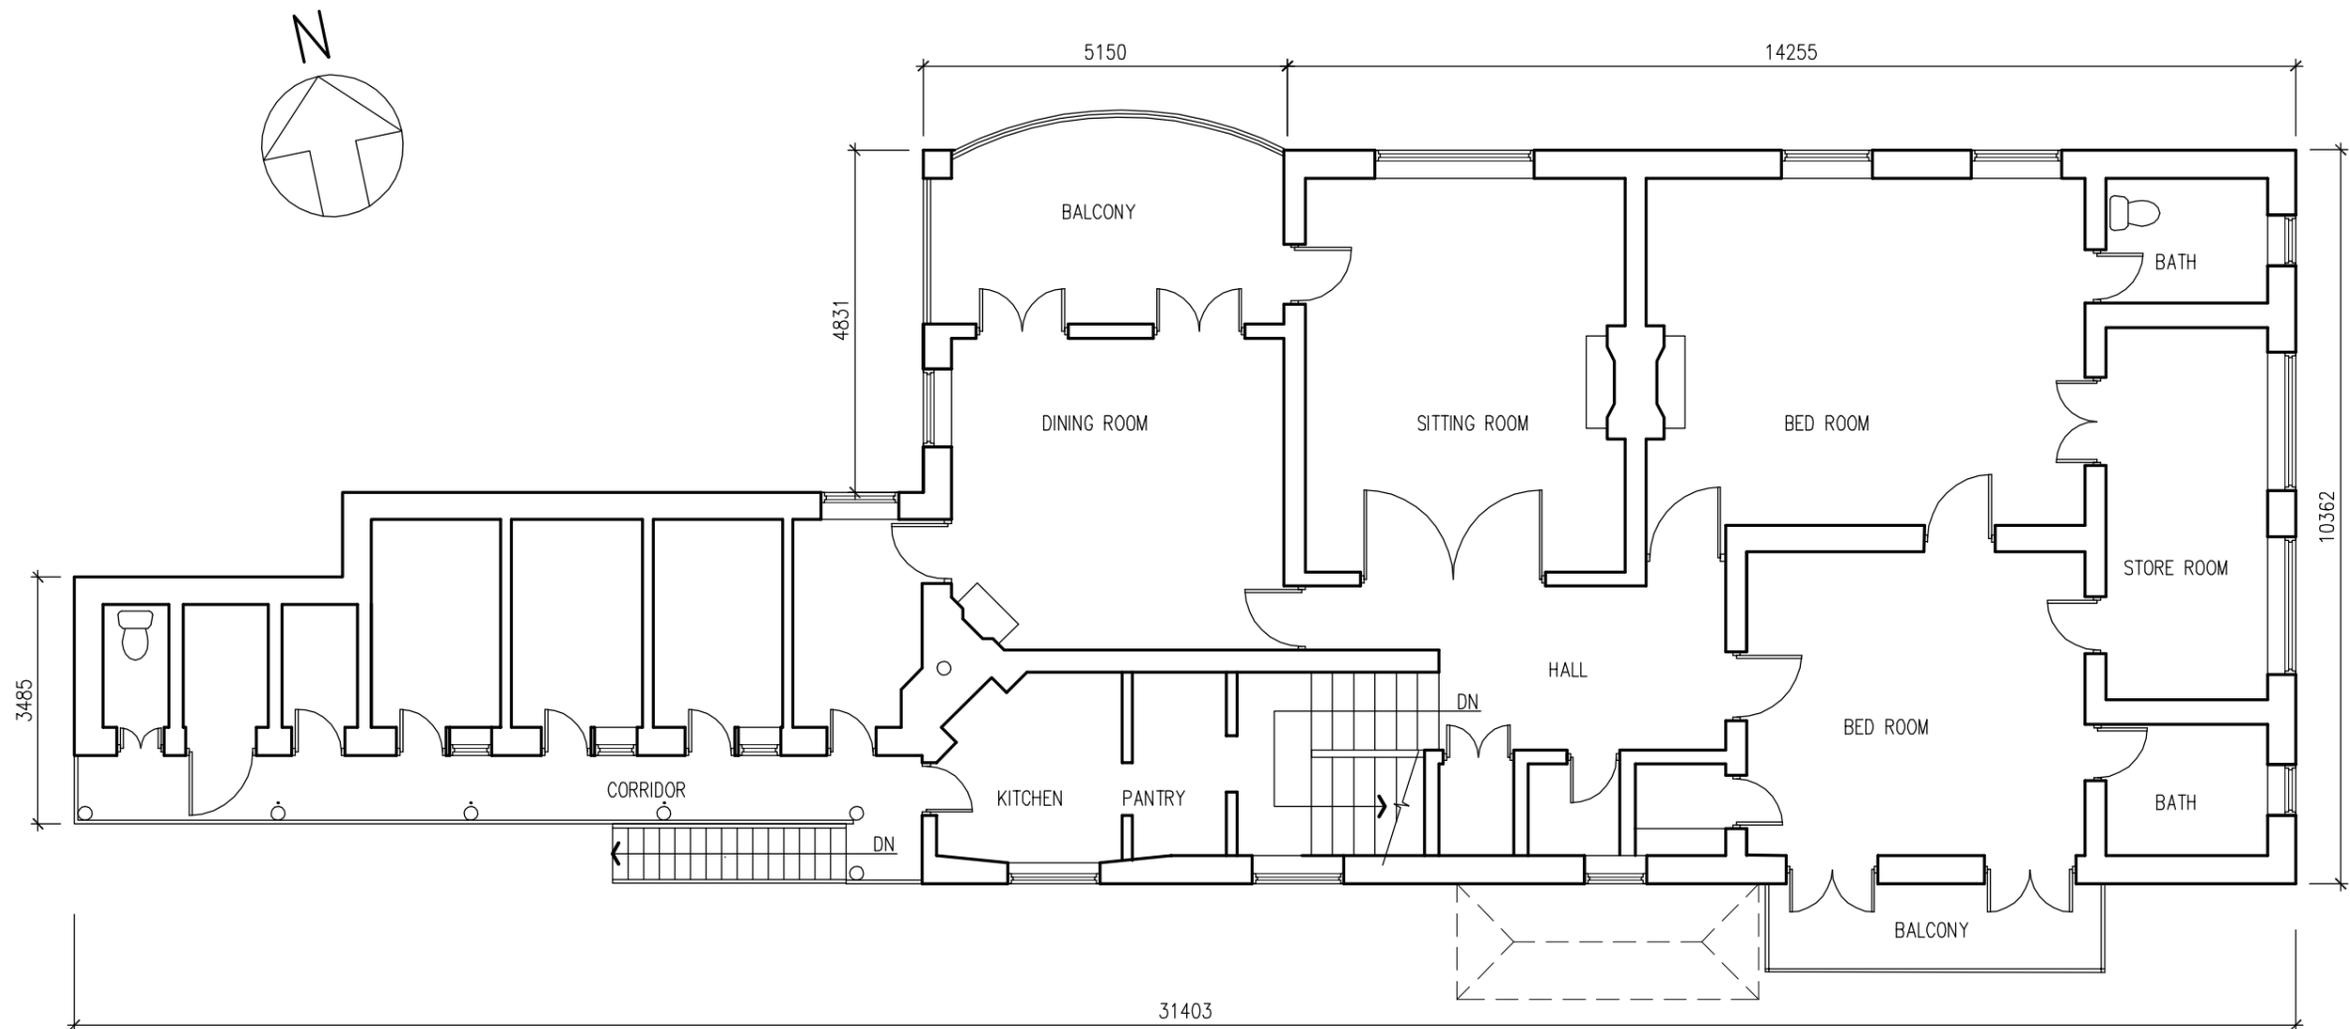
Scale	1 : 100 (A3 size drawing)
Drawing No.	SSQ-02
Date	21 September,2008

**Elliot Pumping Station and Filters
Senior Staff Quarters
First Floor Plan**

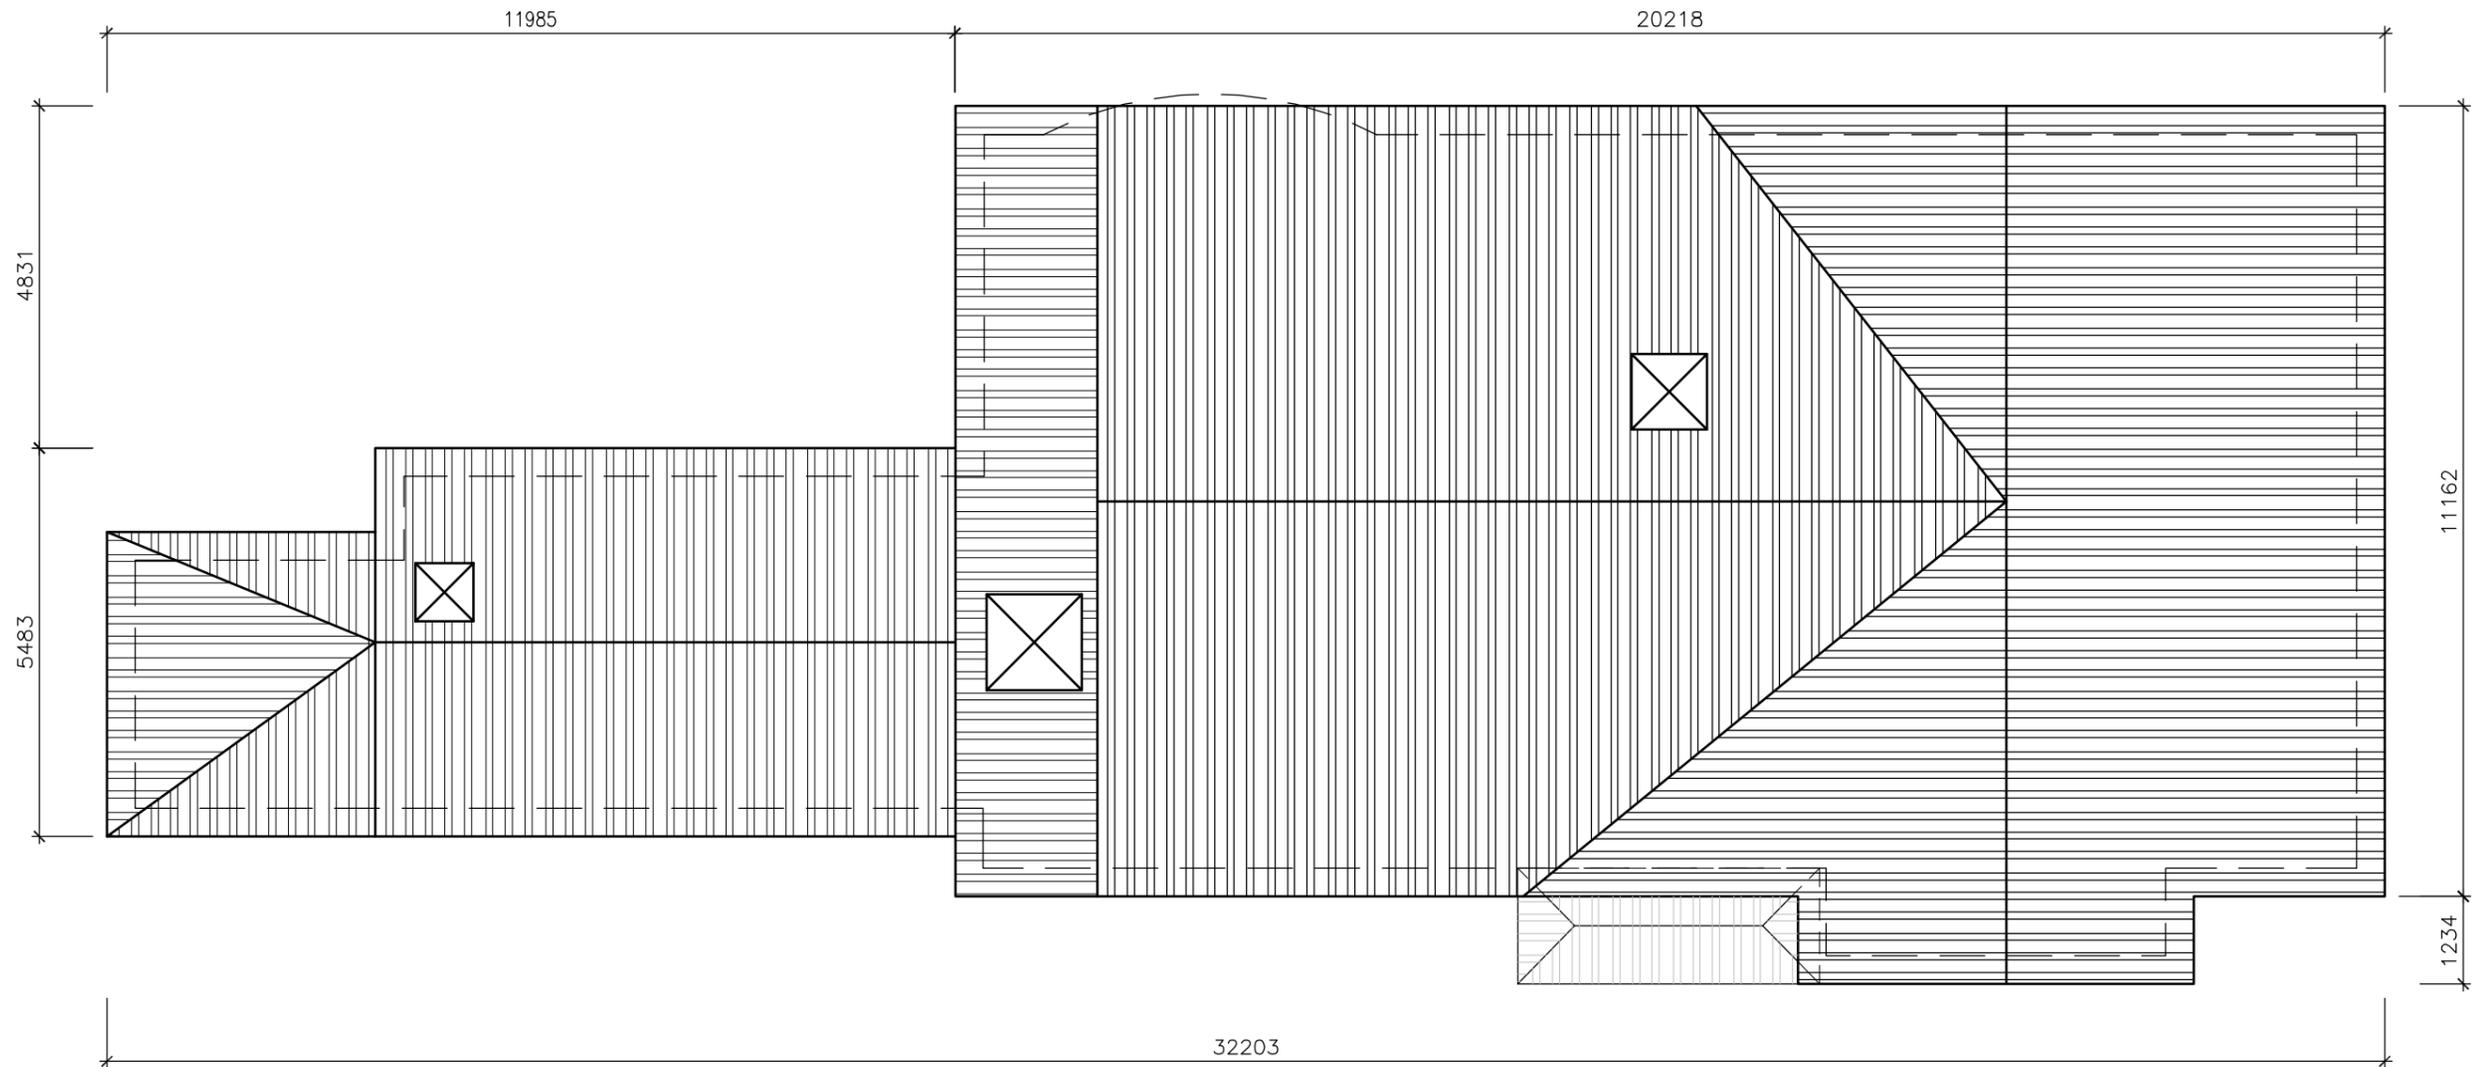
Scale	1 : 100 (A3 size drawing)
Drawing No.	SSQ-03
Date	21 September,2008

**Elliot Pumping Station and Filters
Senior Staff Quarters
Roof Plan**
