Heritage Impact Assessment for Centennial Campus Project, The University of Hong Kong

prepared in accordance with
DEVB Technical Circular (Works) No. 11/2007,
the Guidelines for Built Heritage Impact Assessment (BHIA)
(as at 16 May 2008)

Revision	4
Issue status	Issued
Prepared by	Ivan Ho of The Team Consultant
Approved by	Robert Lam of Wong & Ouyang (HK) Limited
Date	2 nd December, 2008
Total number of pages in main report	30
Total number of appendices enclosed	6

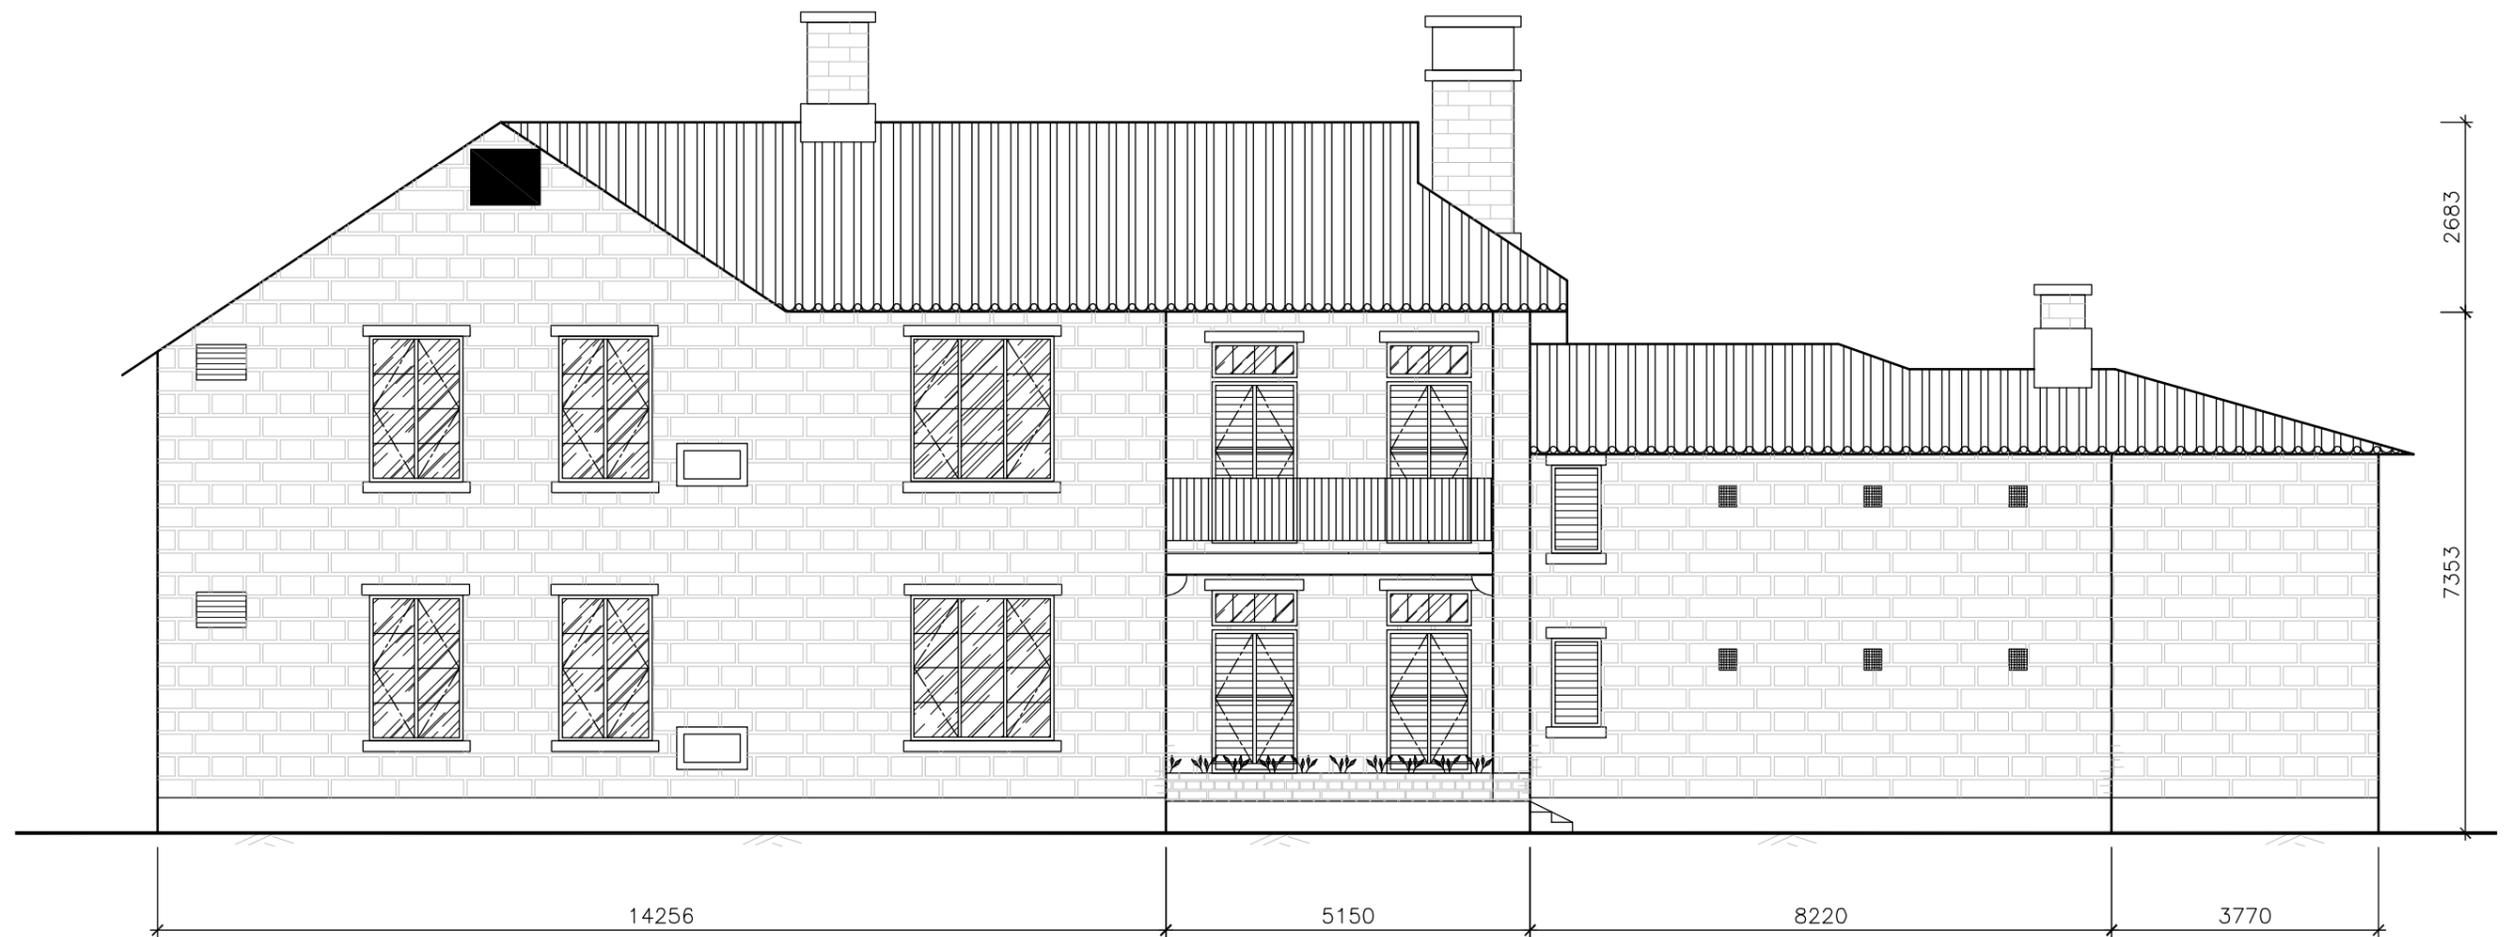
Scale	1 : 100 (A3 size drawing)
Drawing No.	SSQ-04
Date	21 September,2008

Elliot Pumping Station and Filters
Senior Staff Quarters
North (front) Elevation

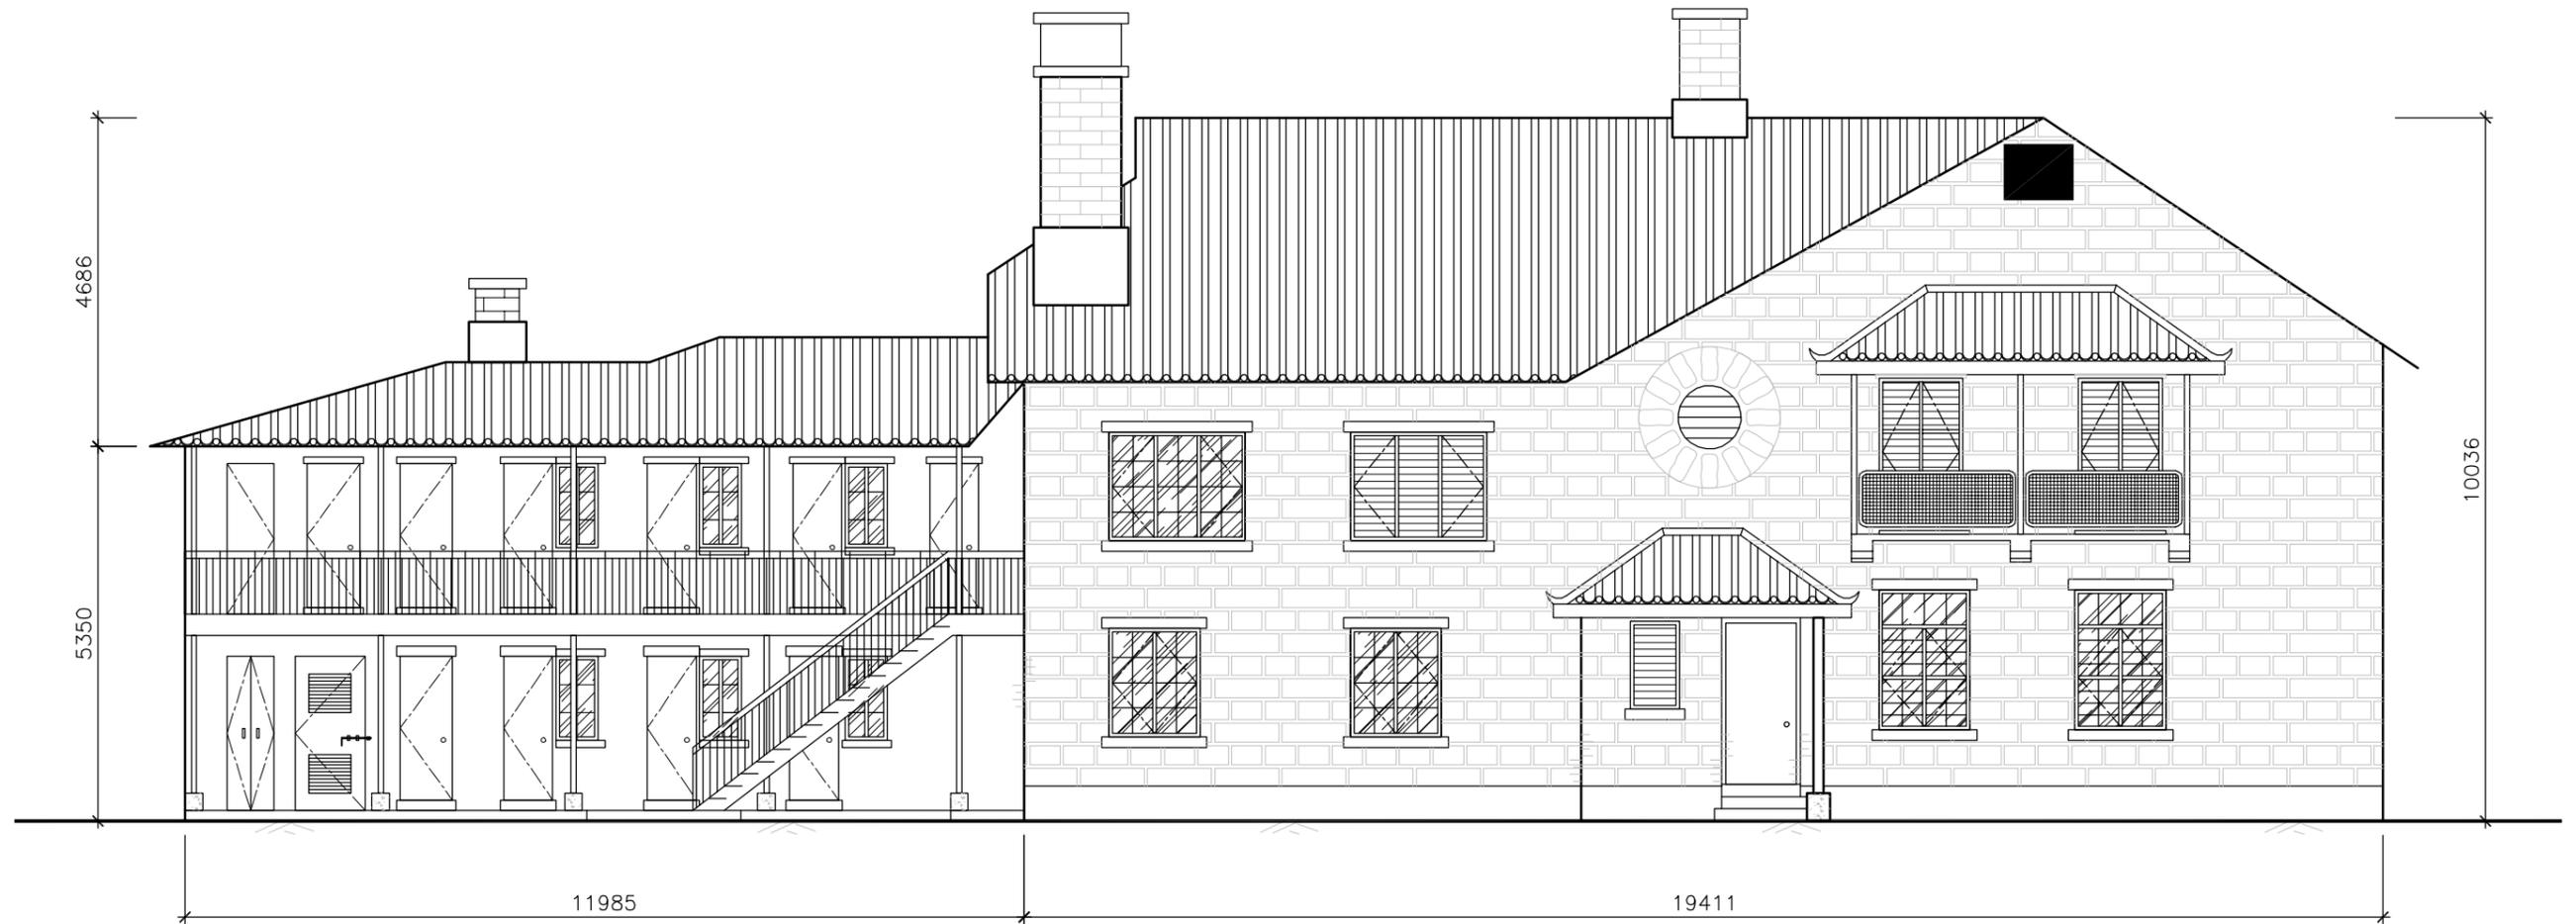
Scale	1 : 100 (A3 size drawing)
Drawing No.	SSQ-05
Date	21 September, 2008

**Elliot Pumping Station and Filters
Senior Staff Quarters
South (raer) Elevation**

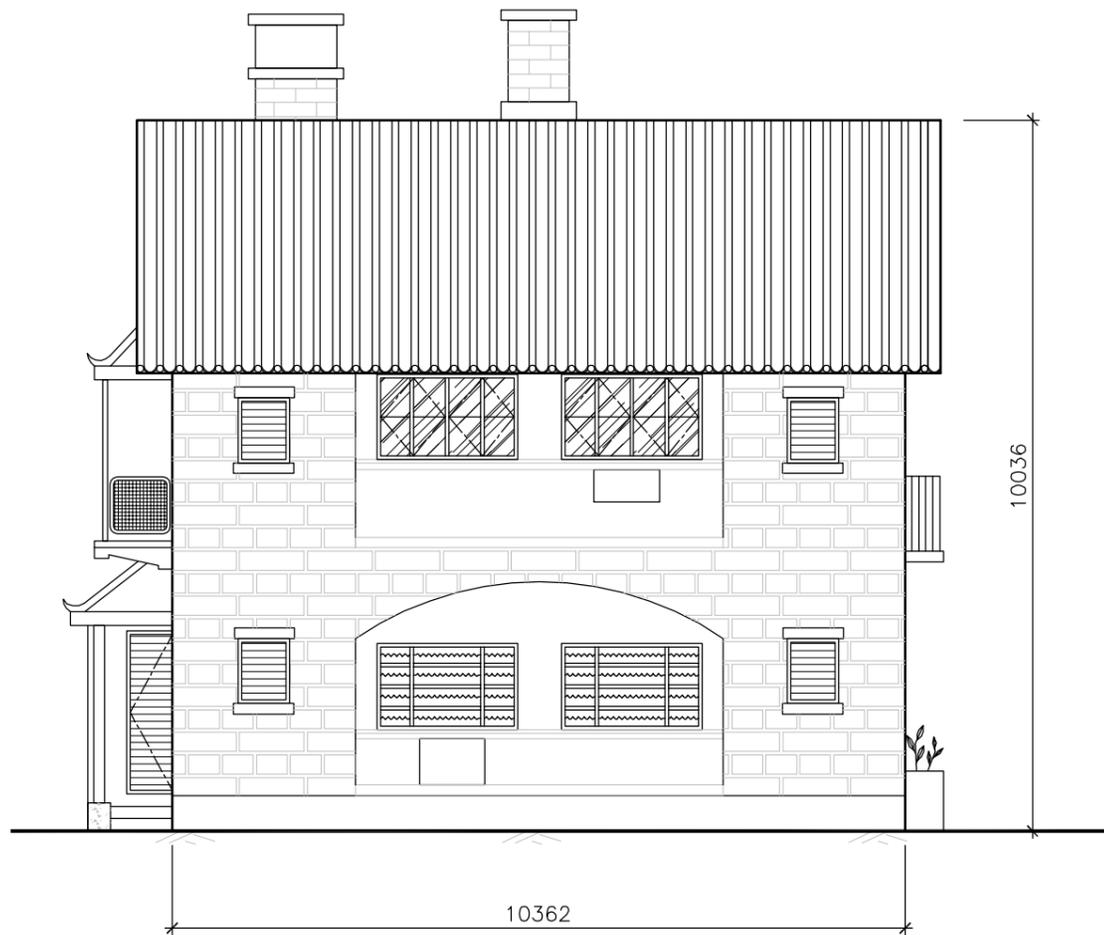
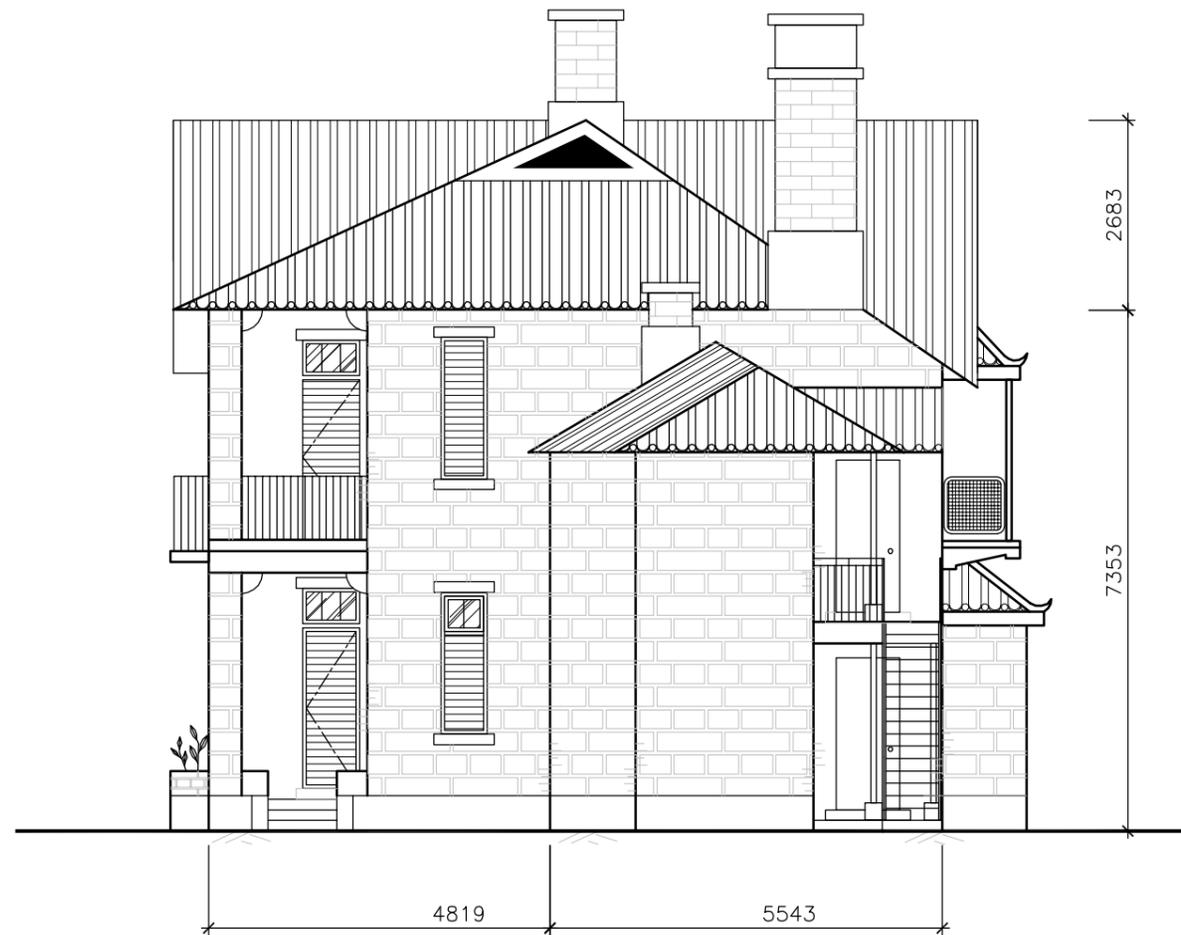
Scale	1 : 100 (A3 size drawing)
Drawing No.	SSQ-06
Date	21 September,2008

**Elliot Pumping Station and Filters
Senior Staff Quarters
East And West Elevations**

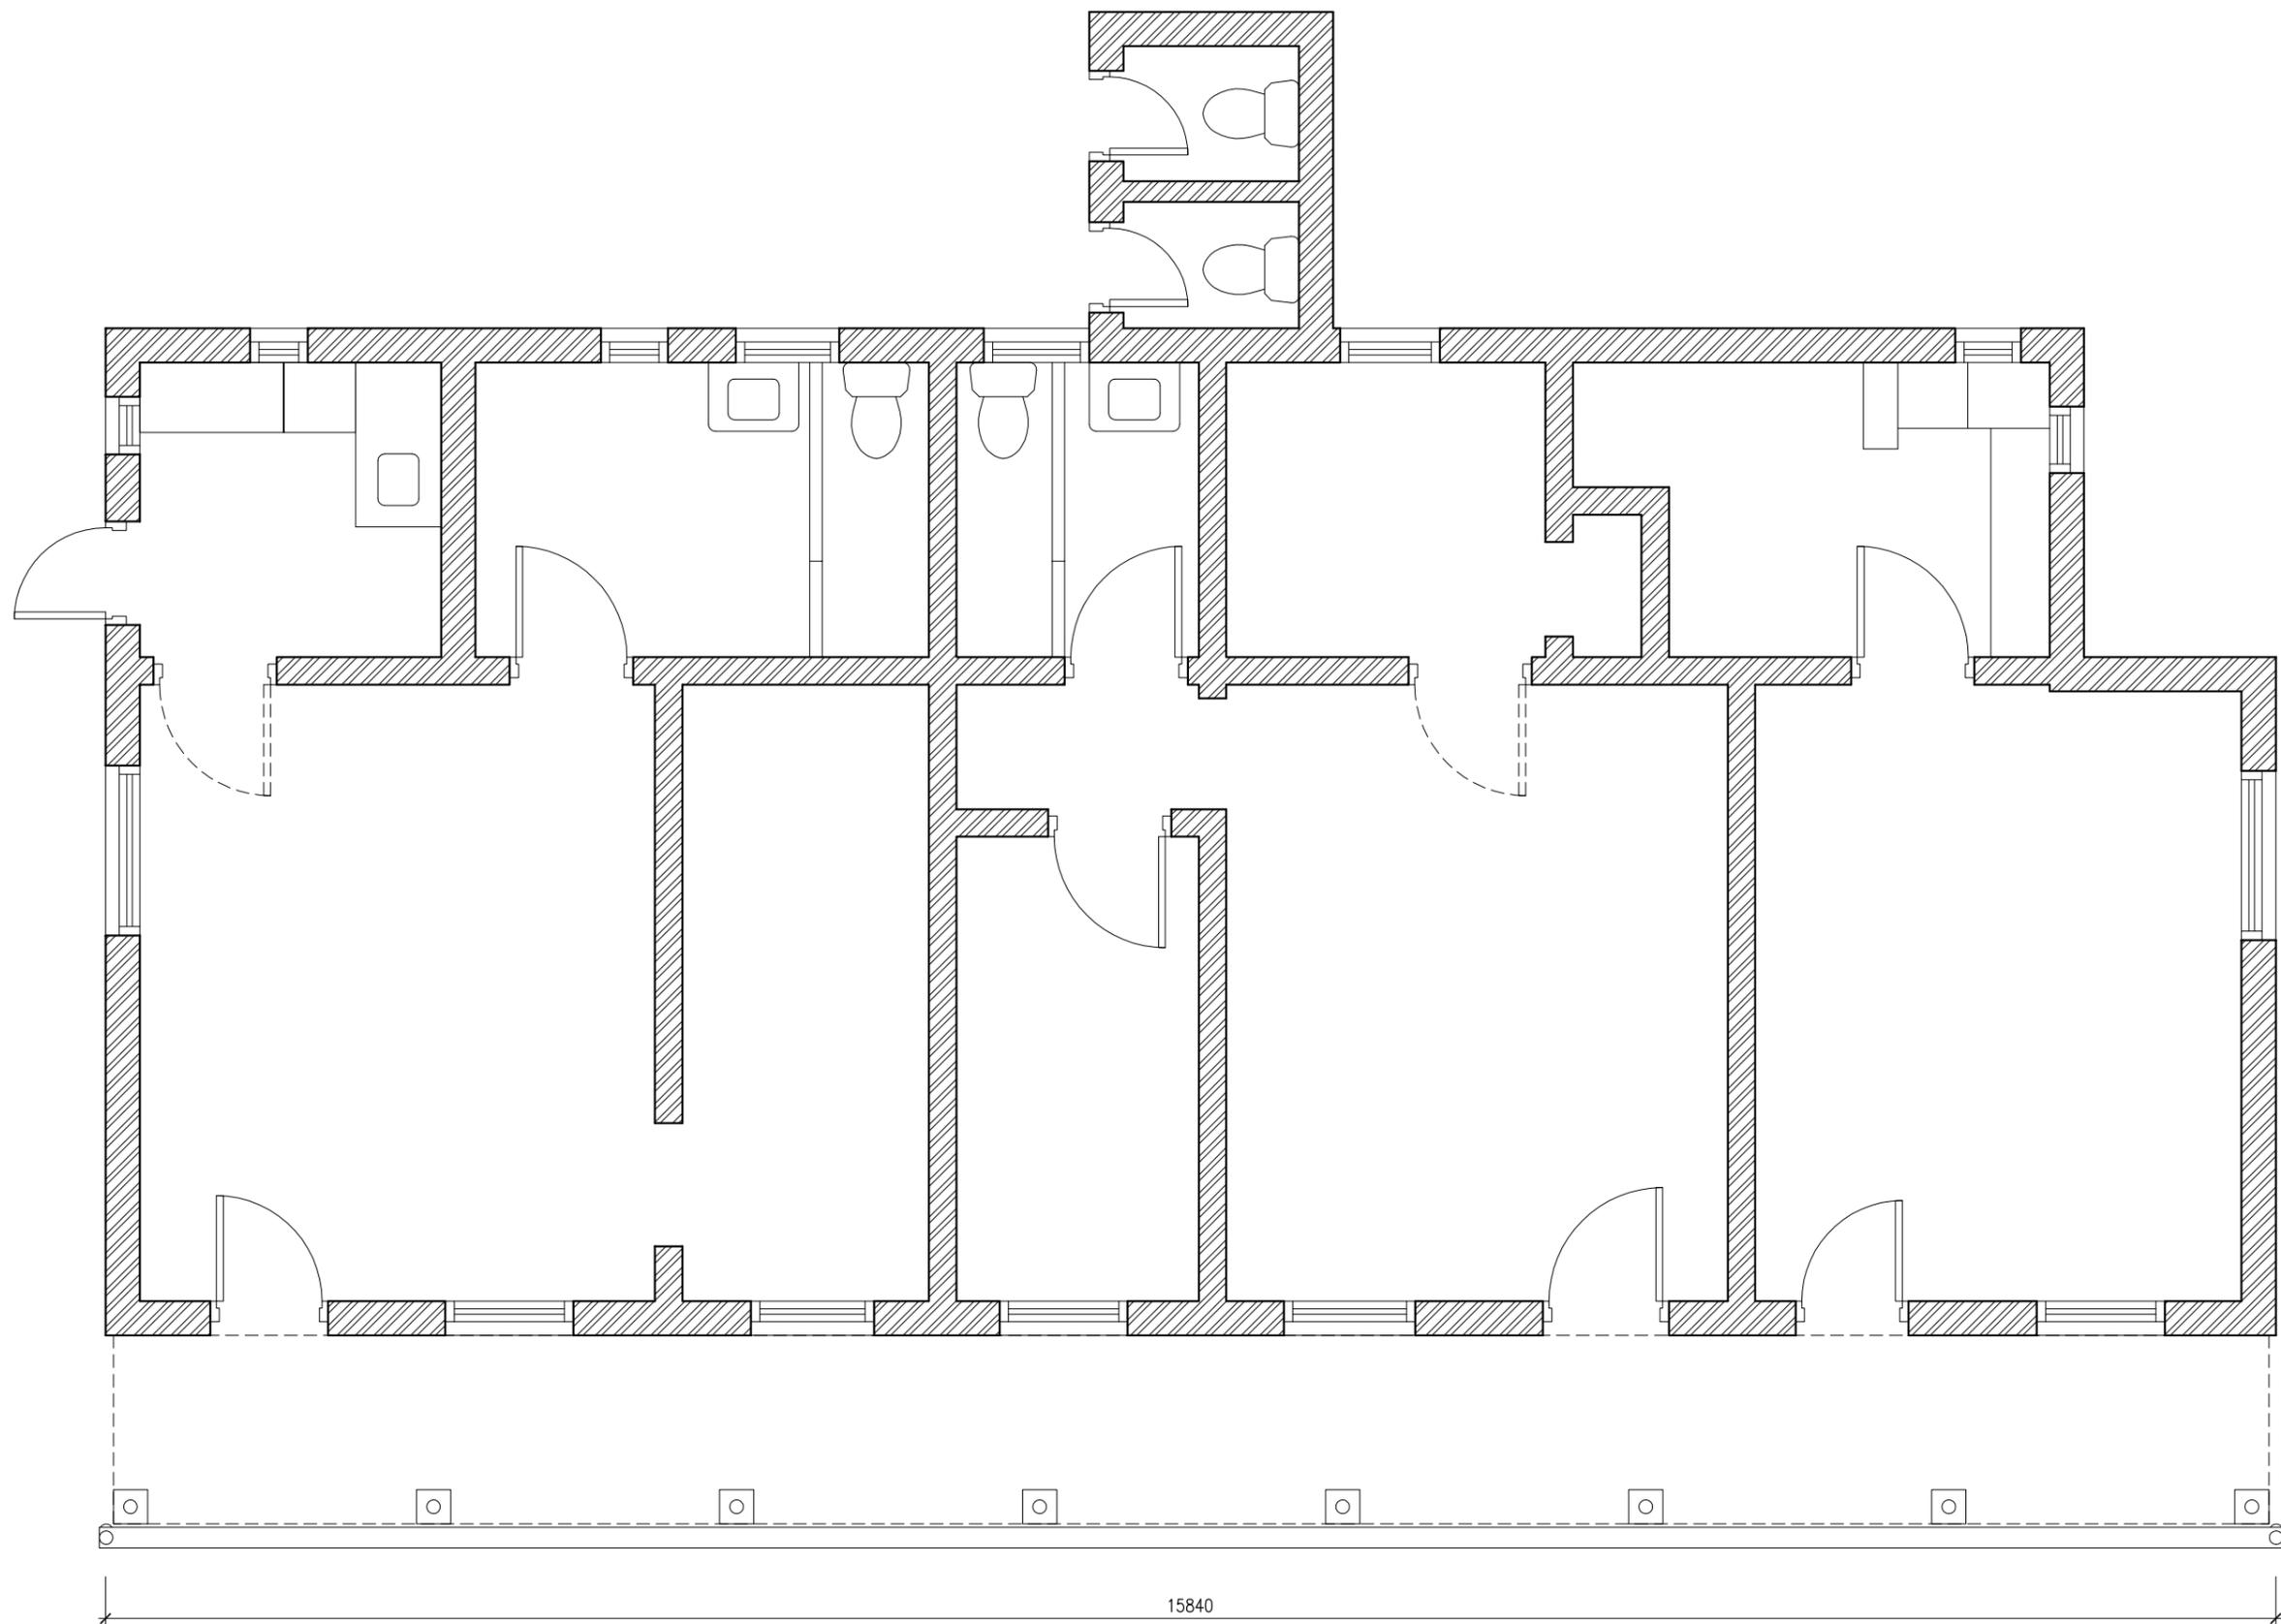
<p>Centennial Campus, The University Of Hong Kong</p>	<p>Elliot Pumping Station and Filters Workmen's Quarters Ground Floor Plan</p>	Scale	1 : 50 (A3 size drawing)
		Drawing No.	WQ-01
		Date	21 September,2008

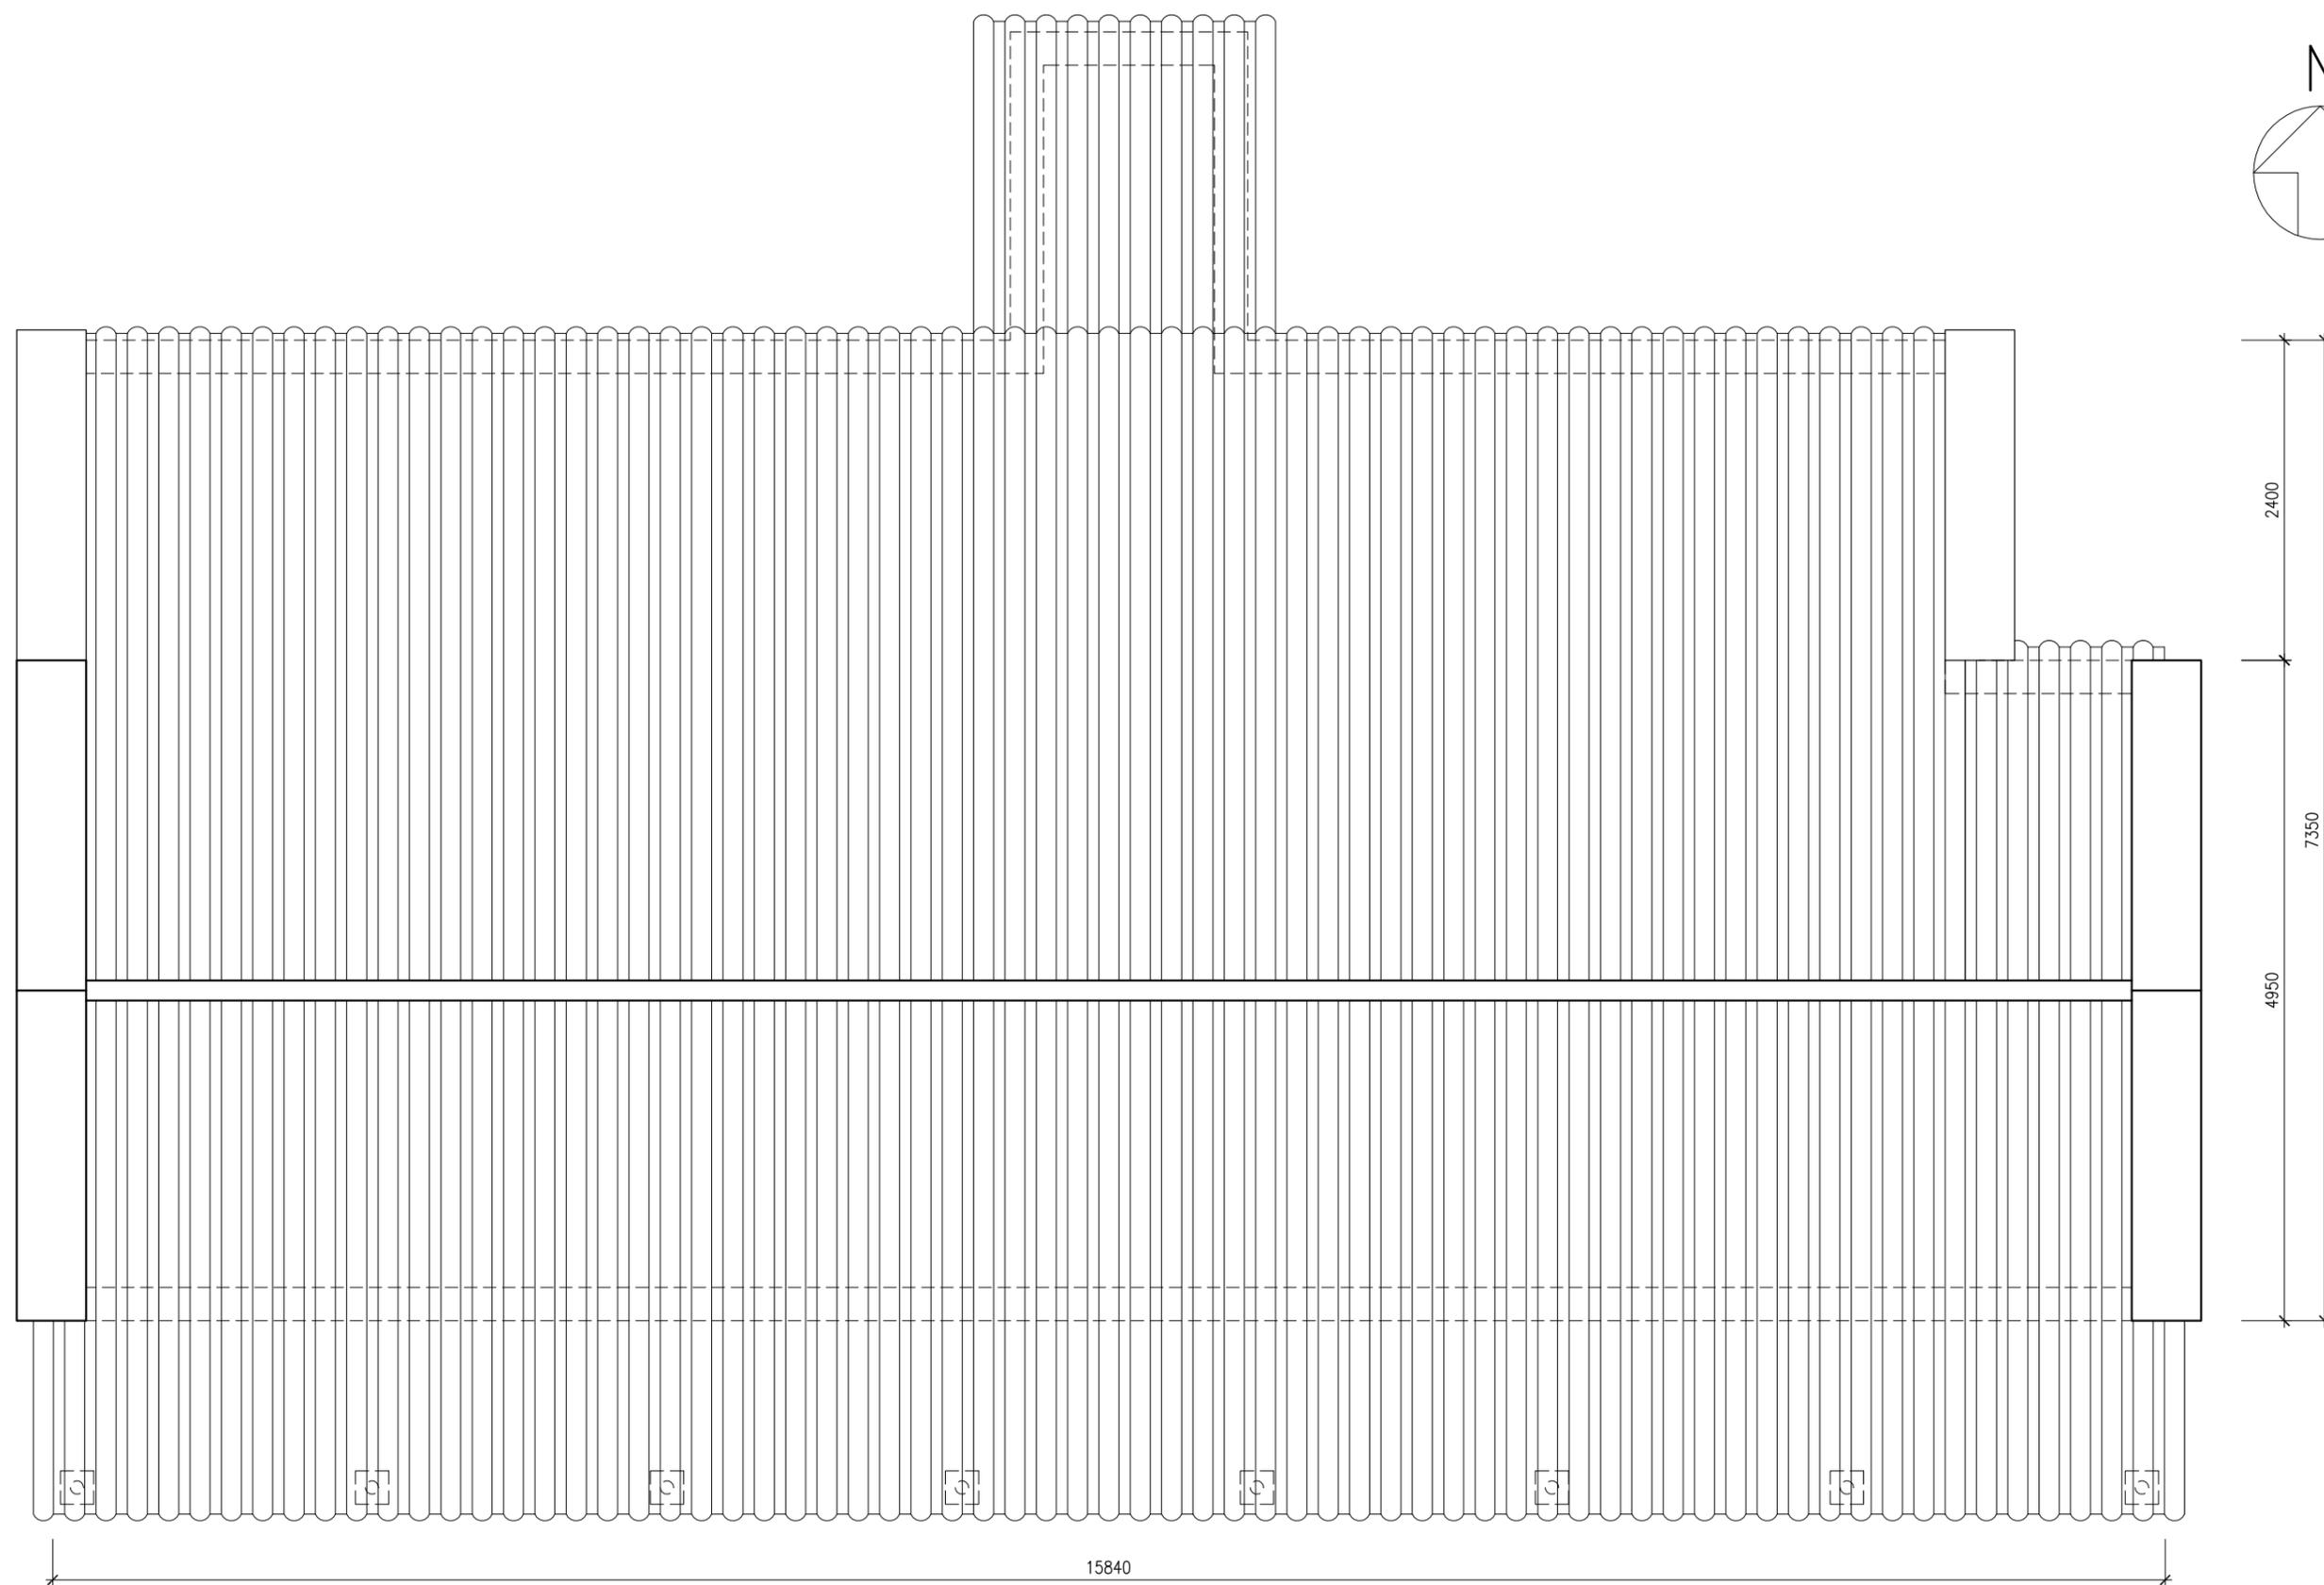
Centennial Campus, The University Of Hong Kong	Elliot Pumping Station and Filters Workmen's Quarters Roof Plan	Scale	1 : 50 (A3 size drawing)
		Drawing No.	WQ-02
		Date	21 September,2008

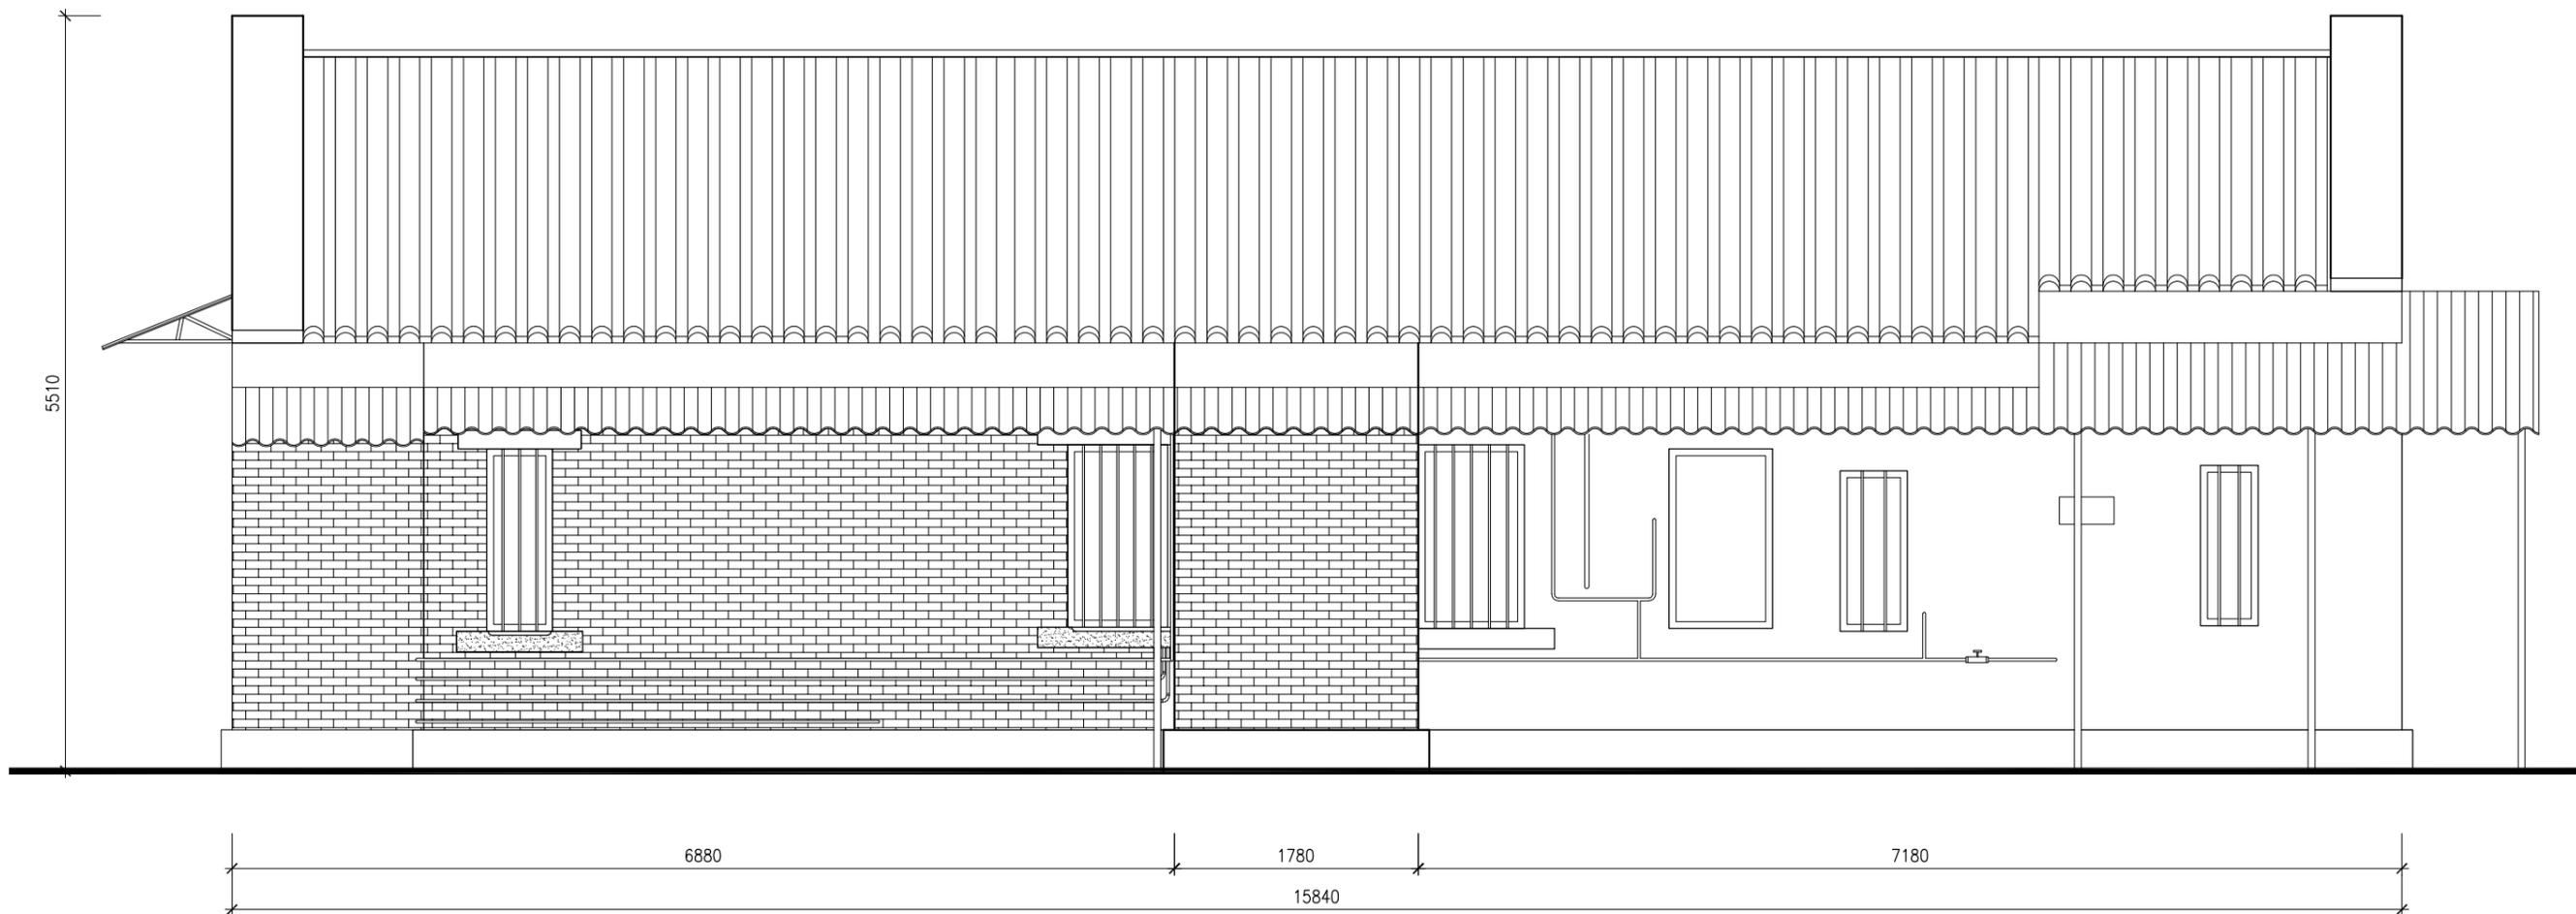
Scale	1 : 50 (A3 size drawing)
Drawing No.	WQ-03
Date	21 September,2008

Elliot Pumping Station and Filters
Workmen's Quarters
North (front) Elevation

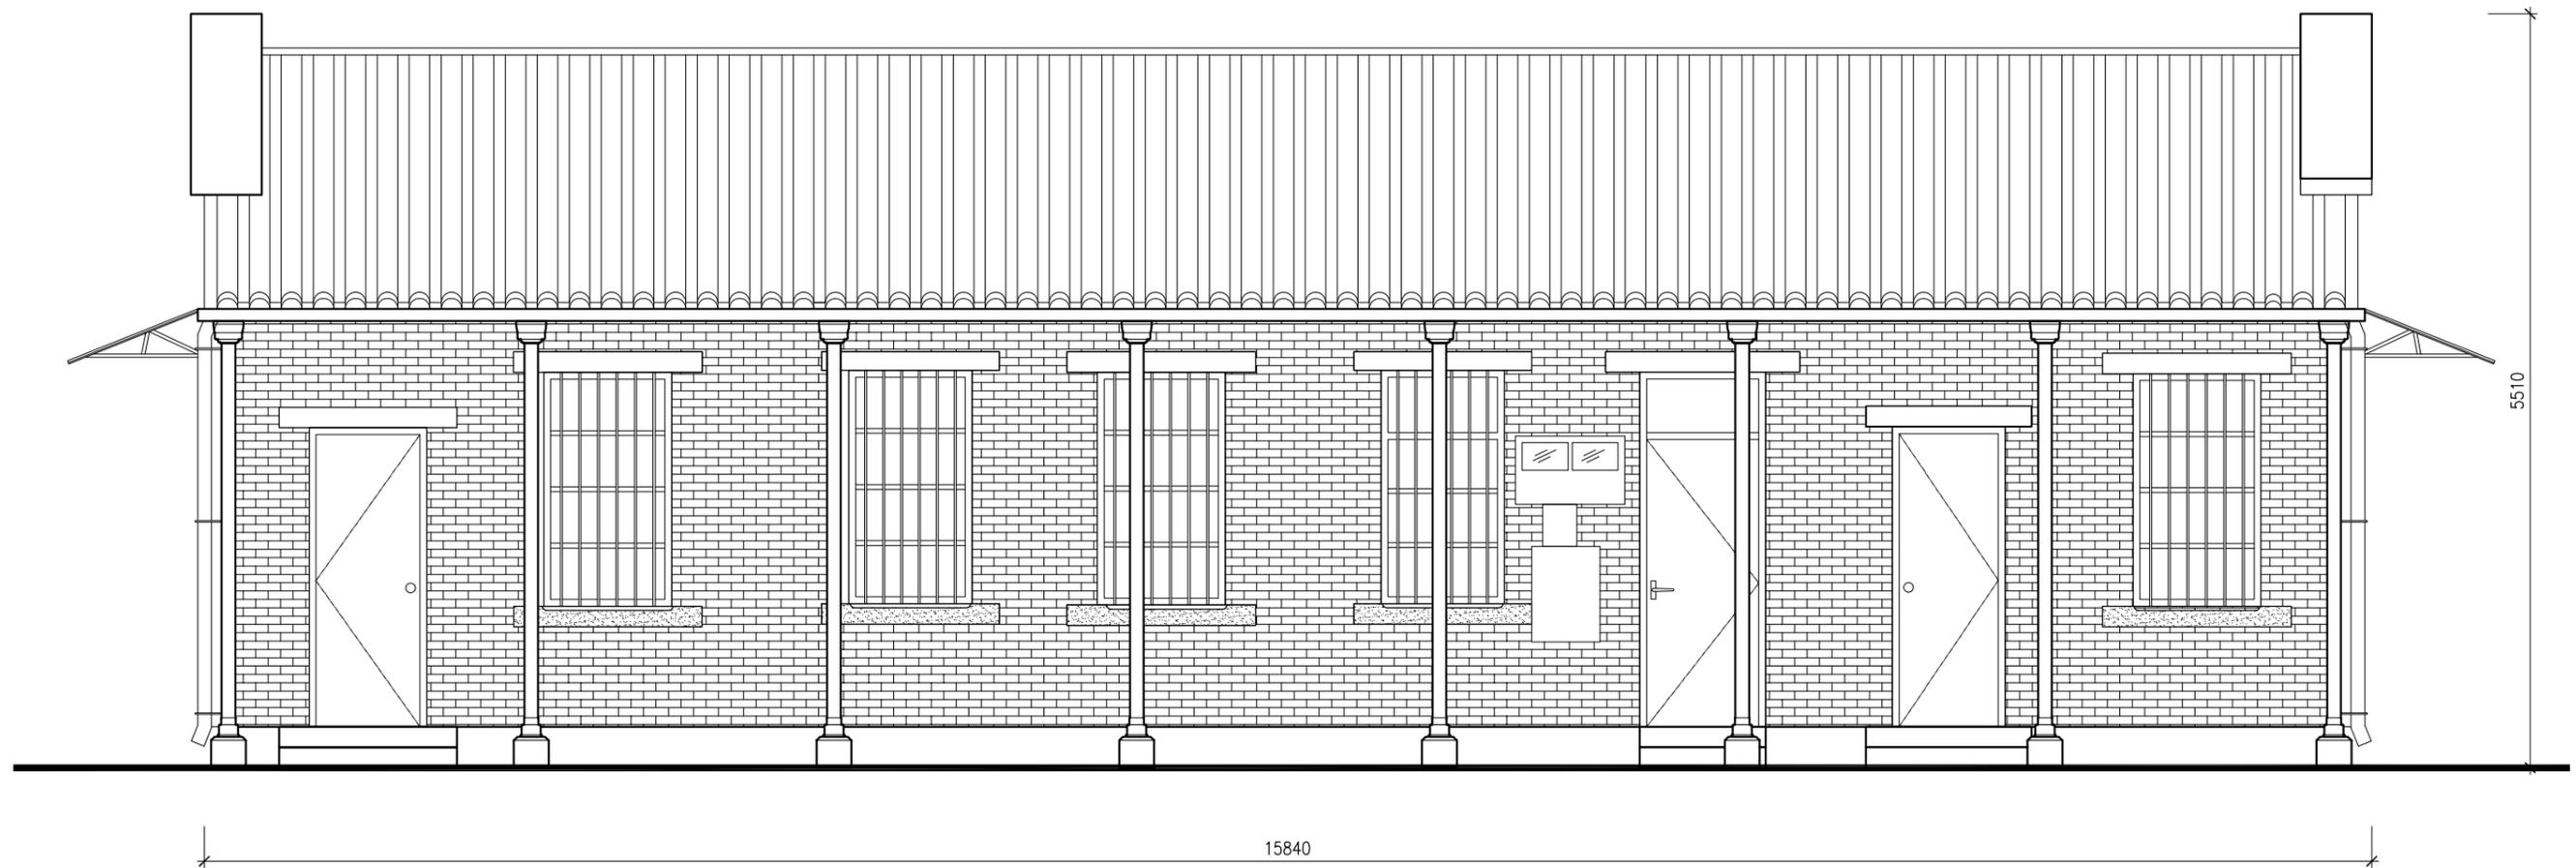
Centennial Campus, The University Of Hong Kong	Elliot Pumping Station and Filters Workmen's Quarters South (rear) Elevation	Scale	1 : 50 (A3 size drawing)
		Drawing No.	WQ-04
		Date	21 September,2008

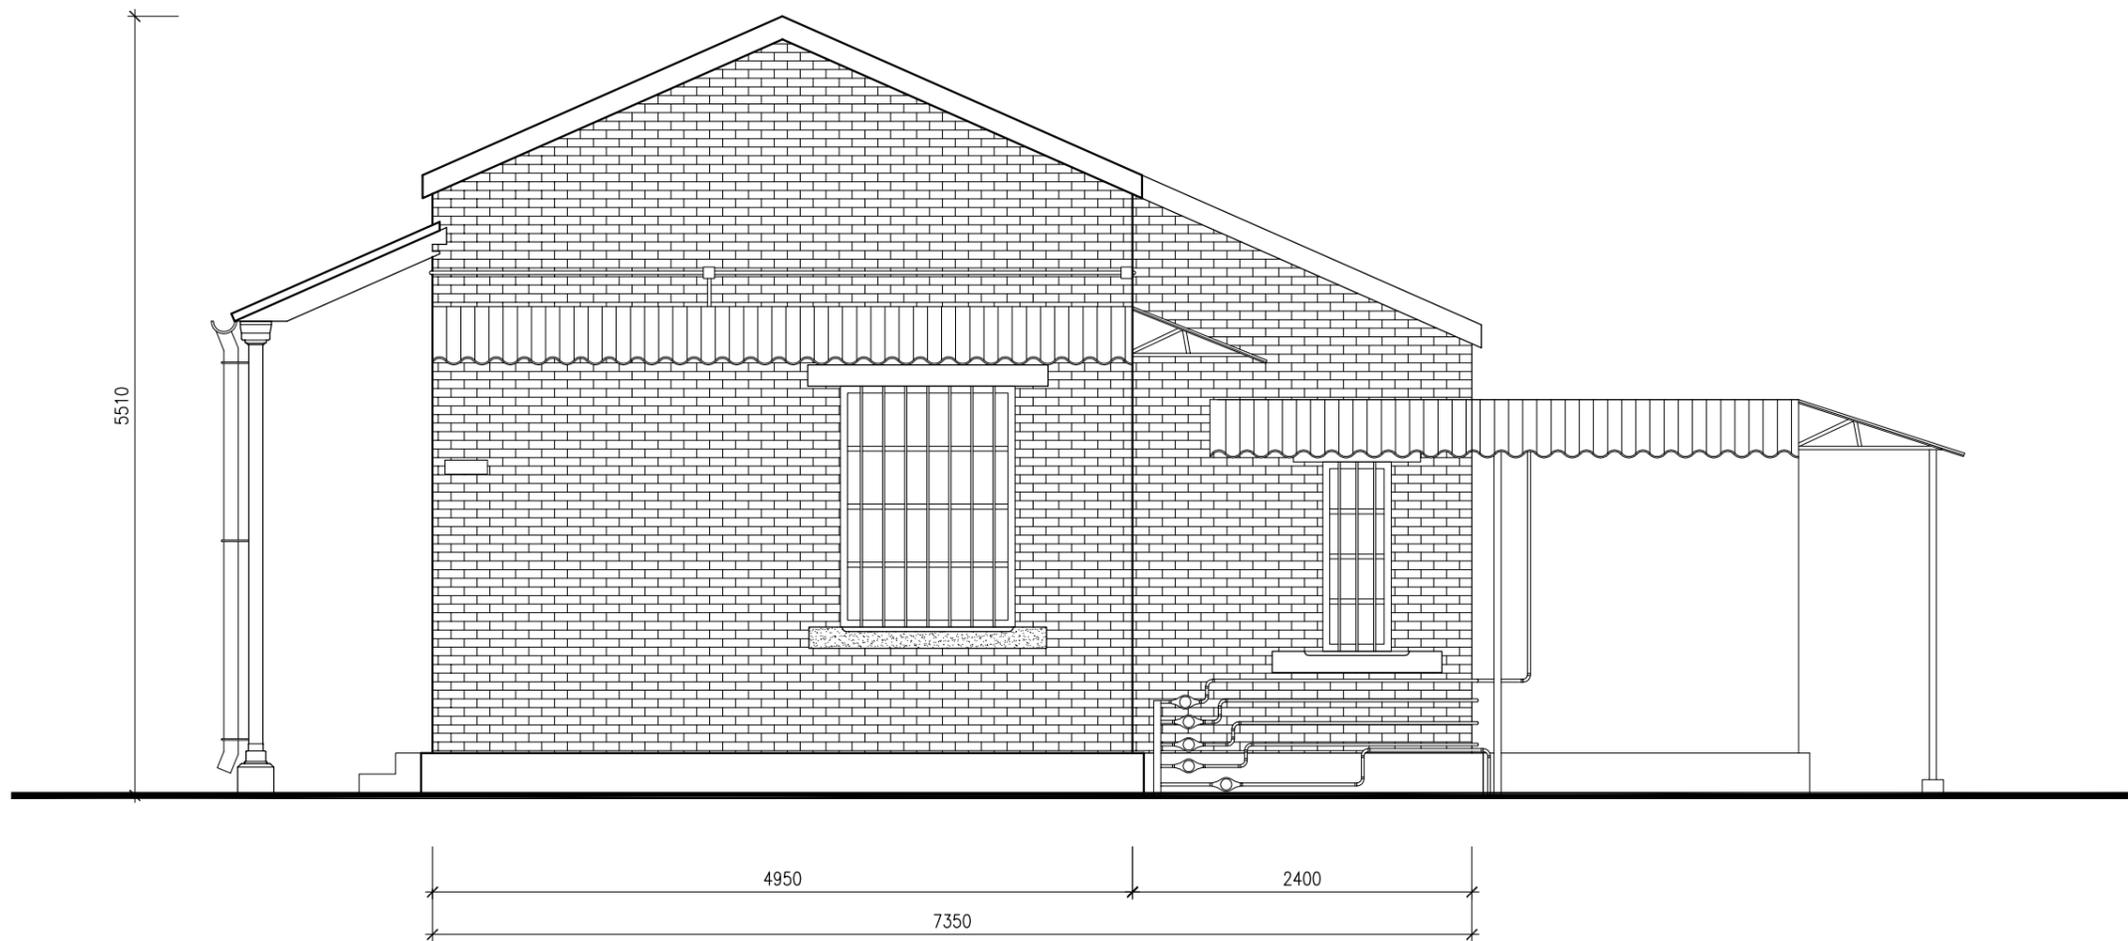
Centennial Campus, The University Of Hong Kong	Elliot Pumping Station and Filters Workmen's Quarters East Elevation	Scale	1 : 50 (A3 size drawing)
		Drawing No.	WQ-05
		Date	21 September,2008

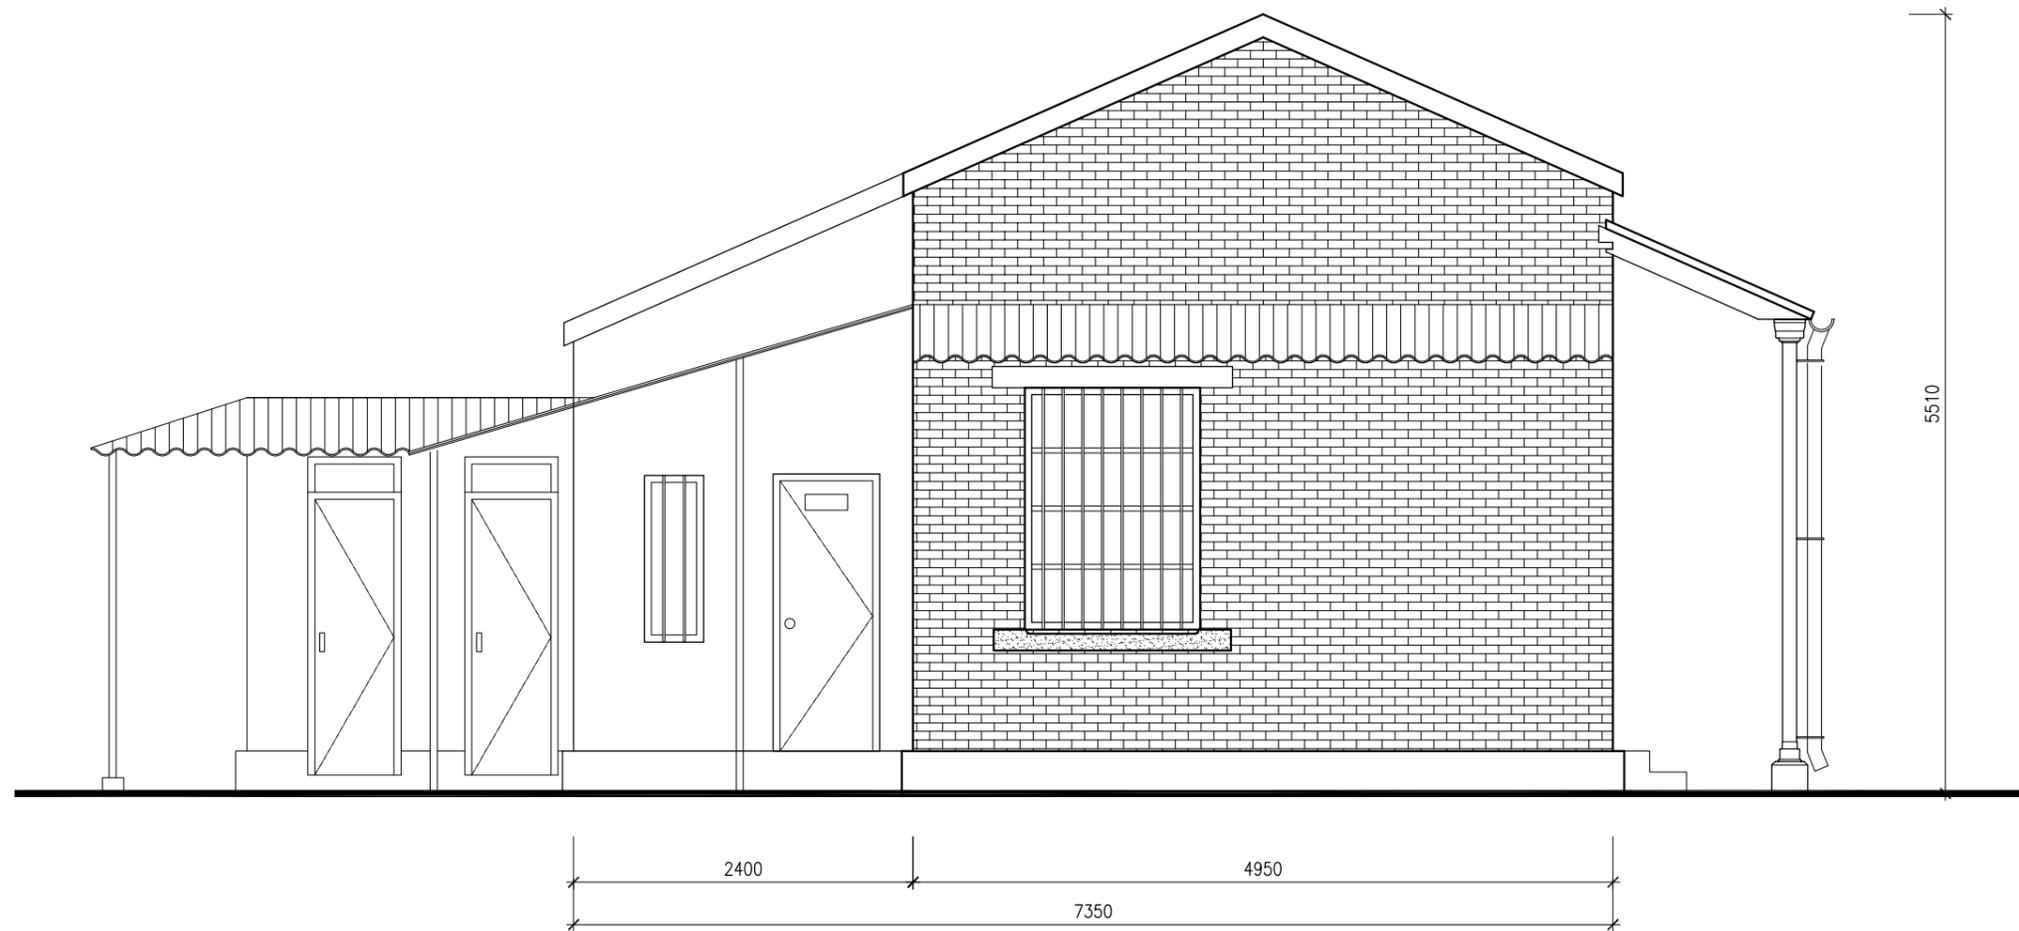
Centennial Campus, The University Of Hong Kong	Elliot Pumping Station and Filters Workmen's Quarters West Elevation	Scale	1 : 50 (A3 size drawing)
		Drawing No.	WQ-06
		Date	21 September,2008
