Heritage Impact Assessment for Centennial Campus Project, The University of Hong Kong

prepared in accordance with
DEVB Technical Circular (Works) No. 11/2007,
the Guidelines for Built Heritage Impact Assessment (BHIA)
(as at 16 May 2008)

Revision	4
Issue status	Issued
Prepared by	Ivan Ho of The Team Consultant
Approved by	Robert Lam of Wong & Ouyang (HK) Limited
Date	2 nd December, 2008
Total number of pages in main report	30
Total number of appendices enclosed	6

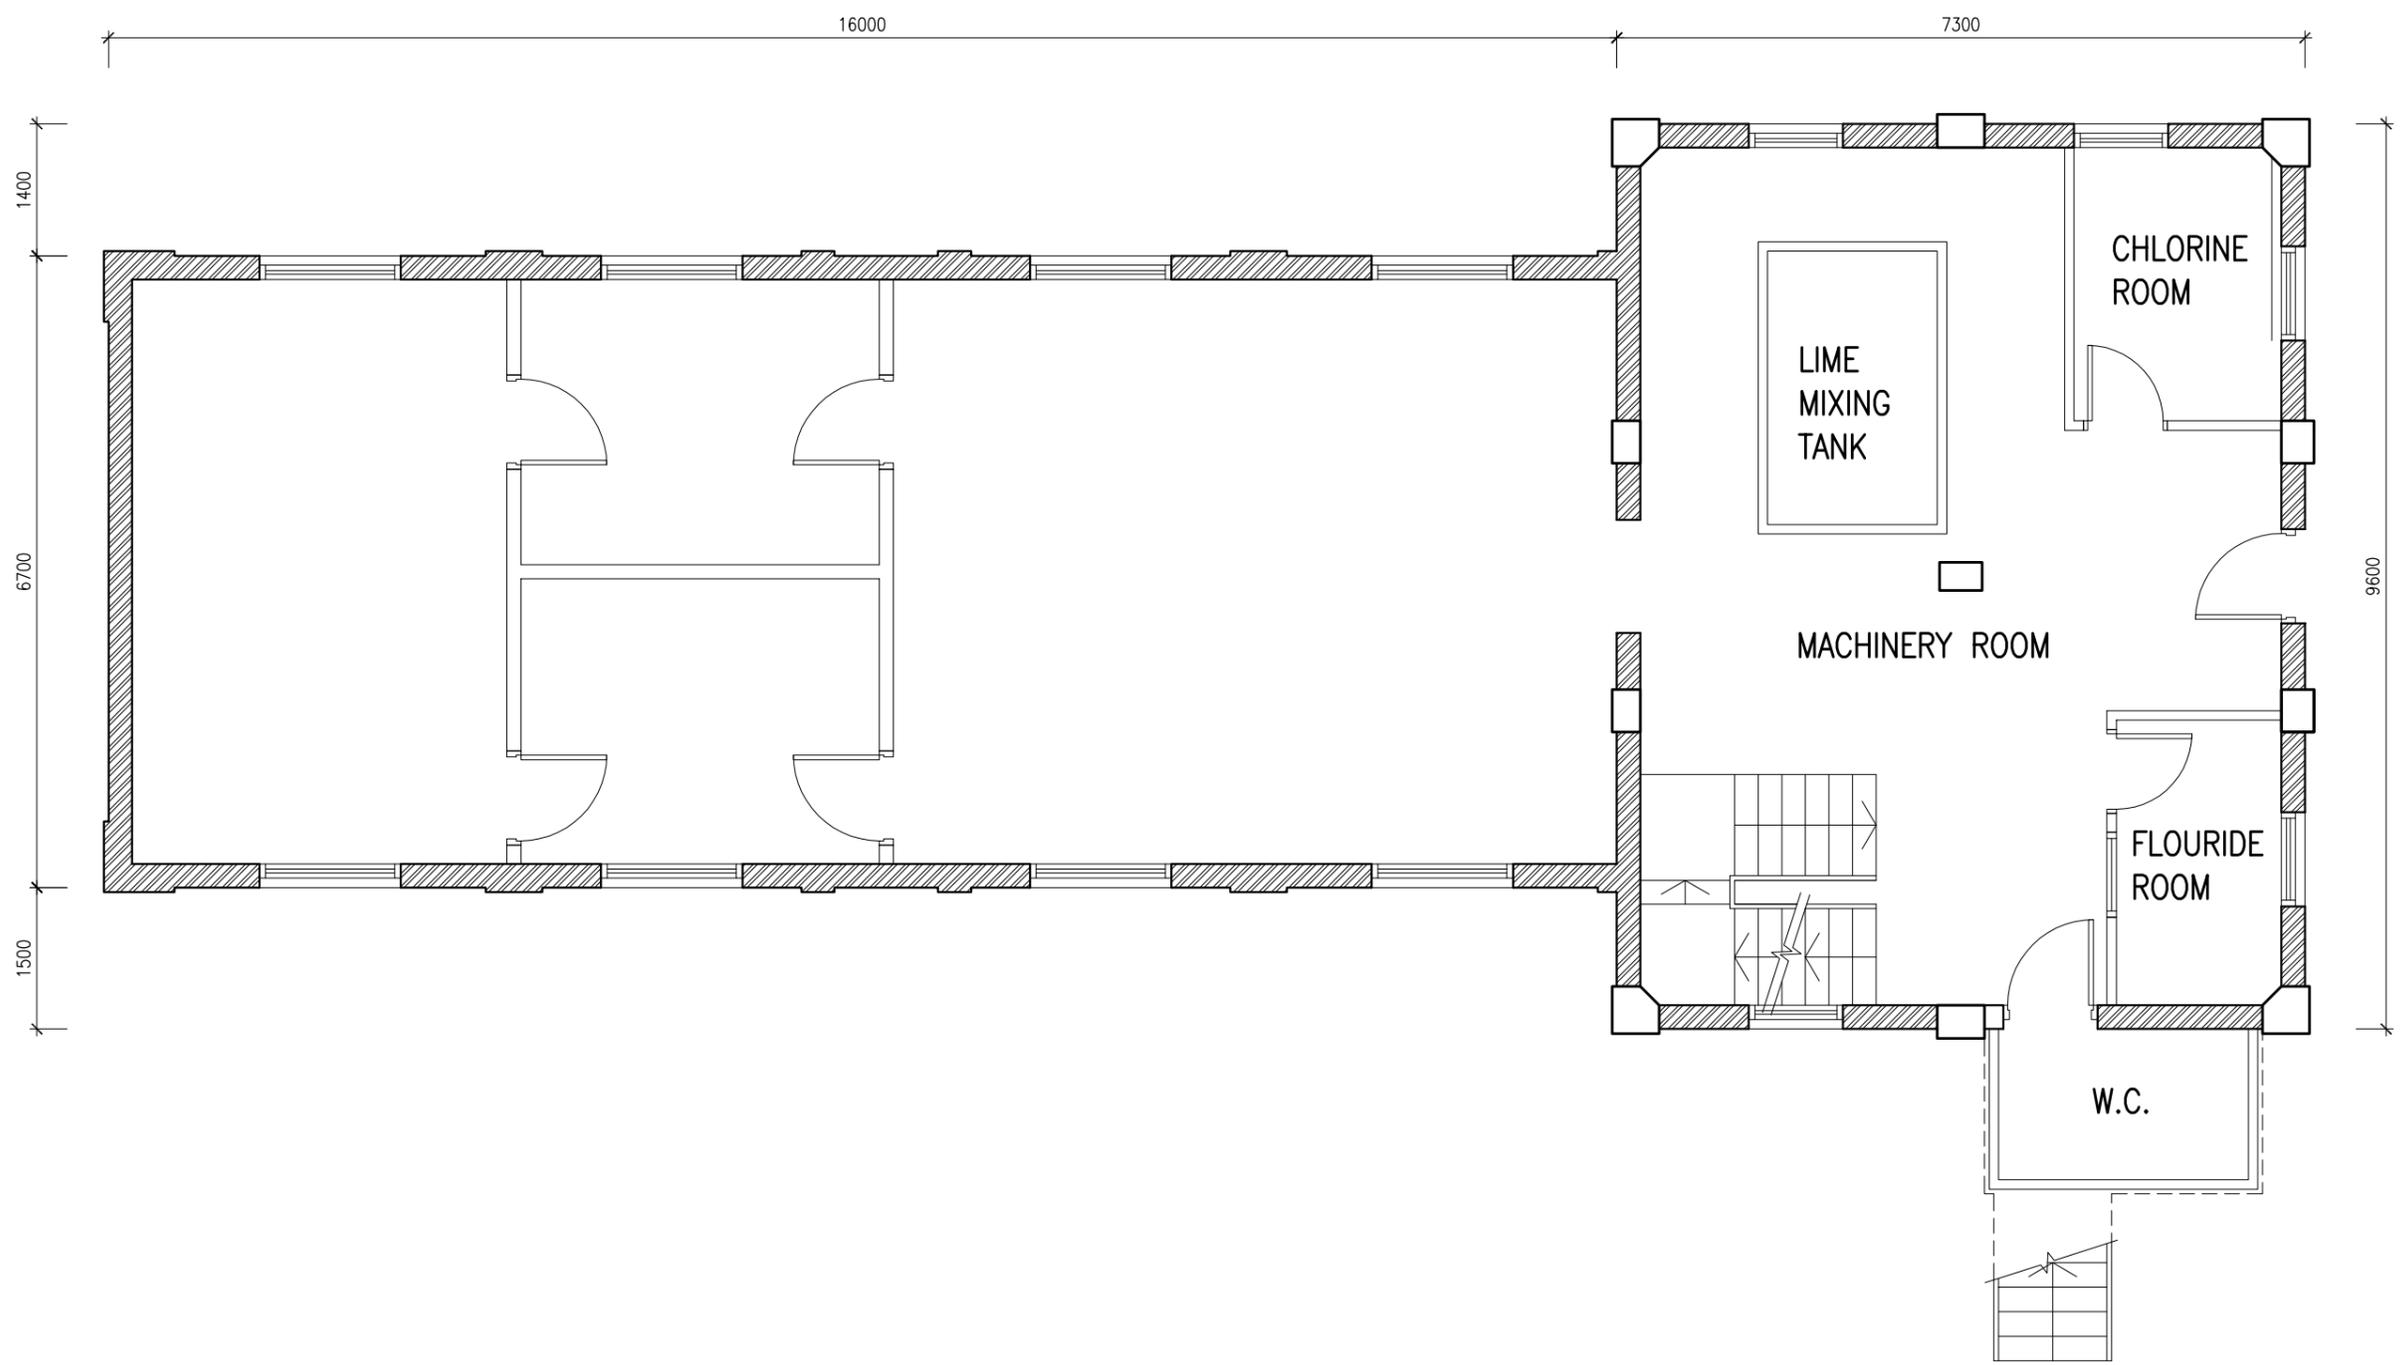
Centennial Campus, The University Of Hong Kong	Elliot Pumping Station and Filters Treatment Works Building Entrance Level Plan	Scale	1 : 75 (A3 size drawing)
		Drawing No.	TWB-02
		Date	21 September,2008

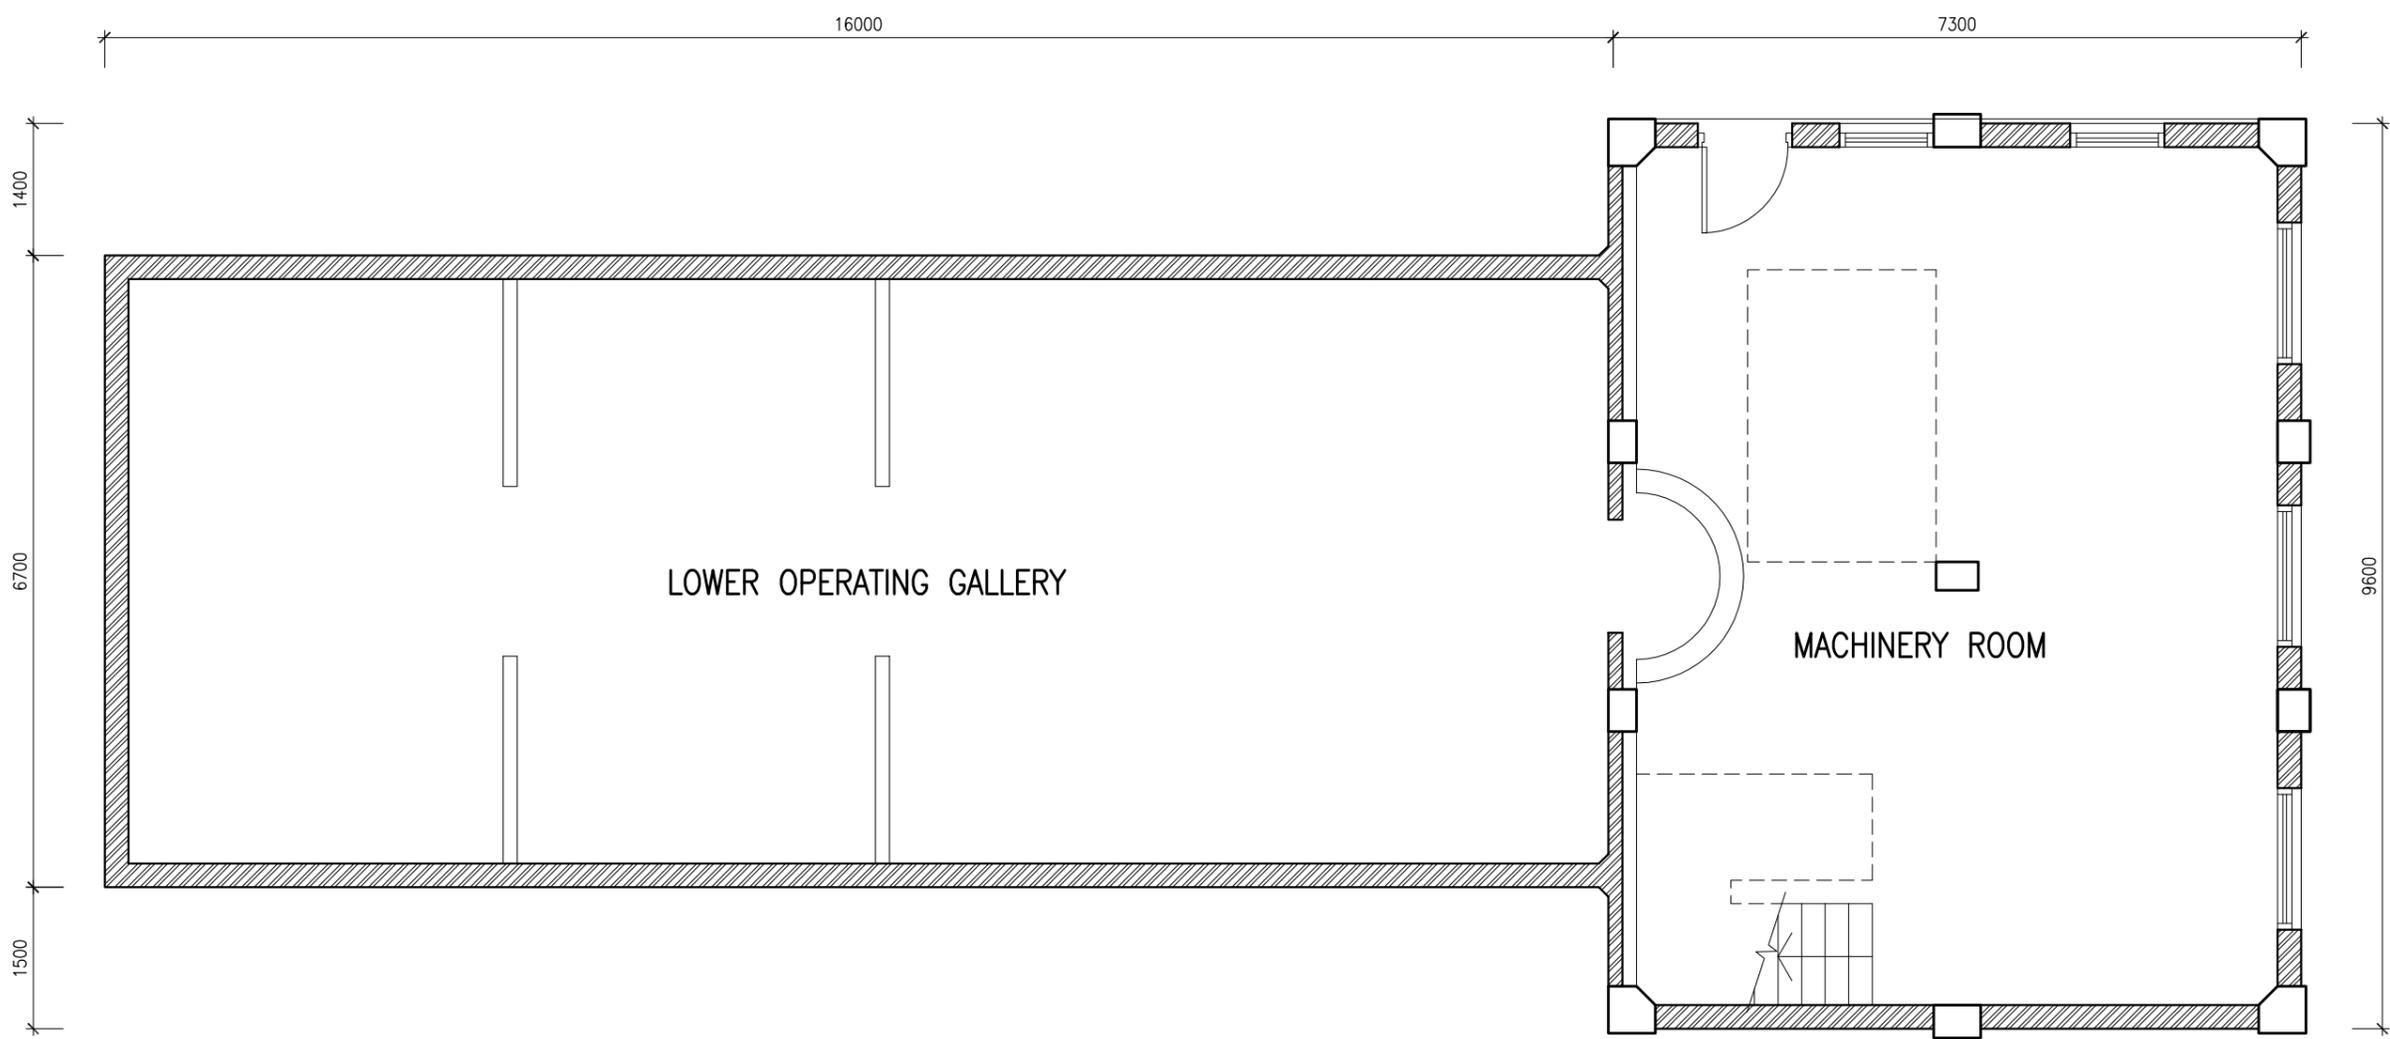
Centennial Campus, The University Of Hong Kong	Elliot Pumping Station and Filters Treatment Works Building Lower Level Plan	Scale	1 : 75 (A3 size drawing)
		Drawing No.	TWB-01
		Date	21 September,2008

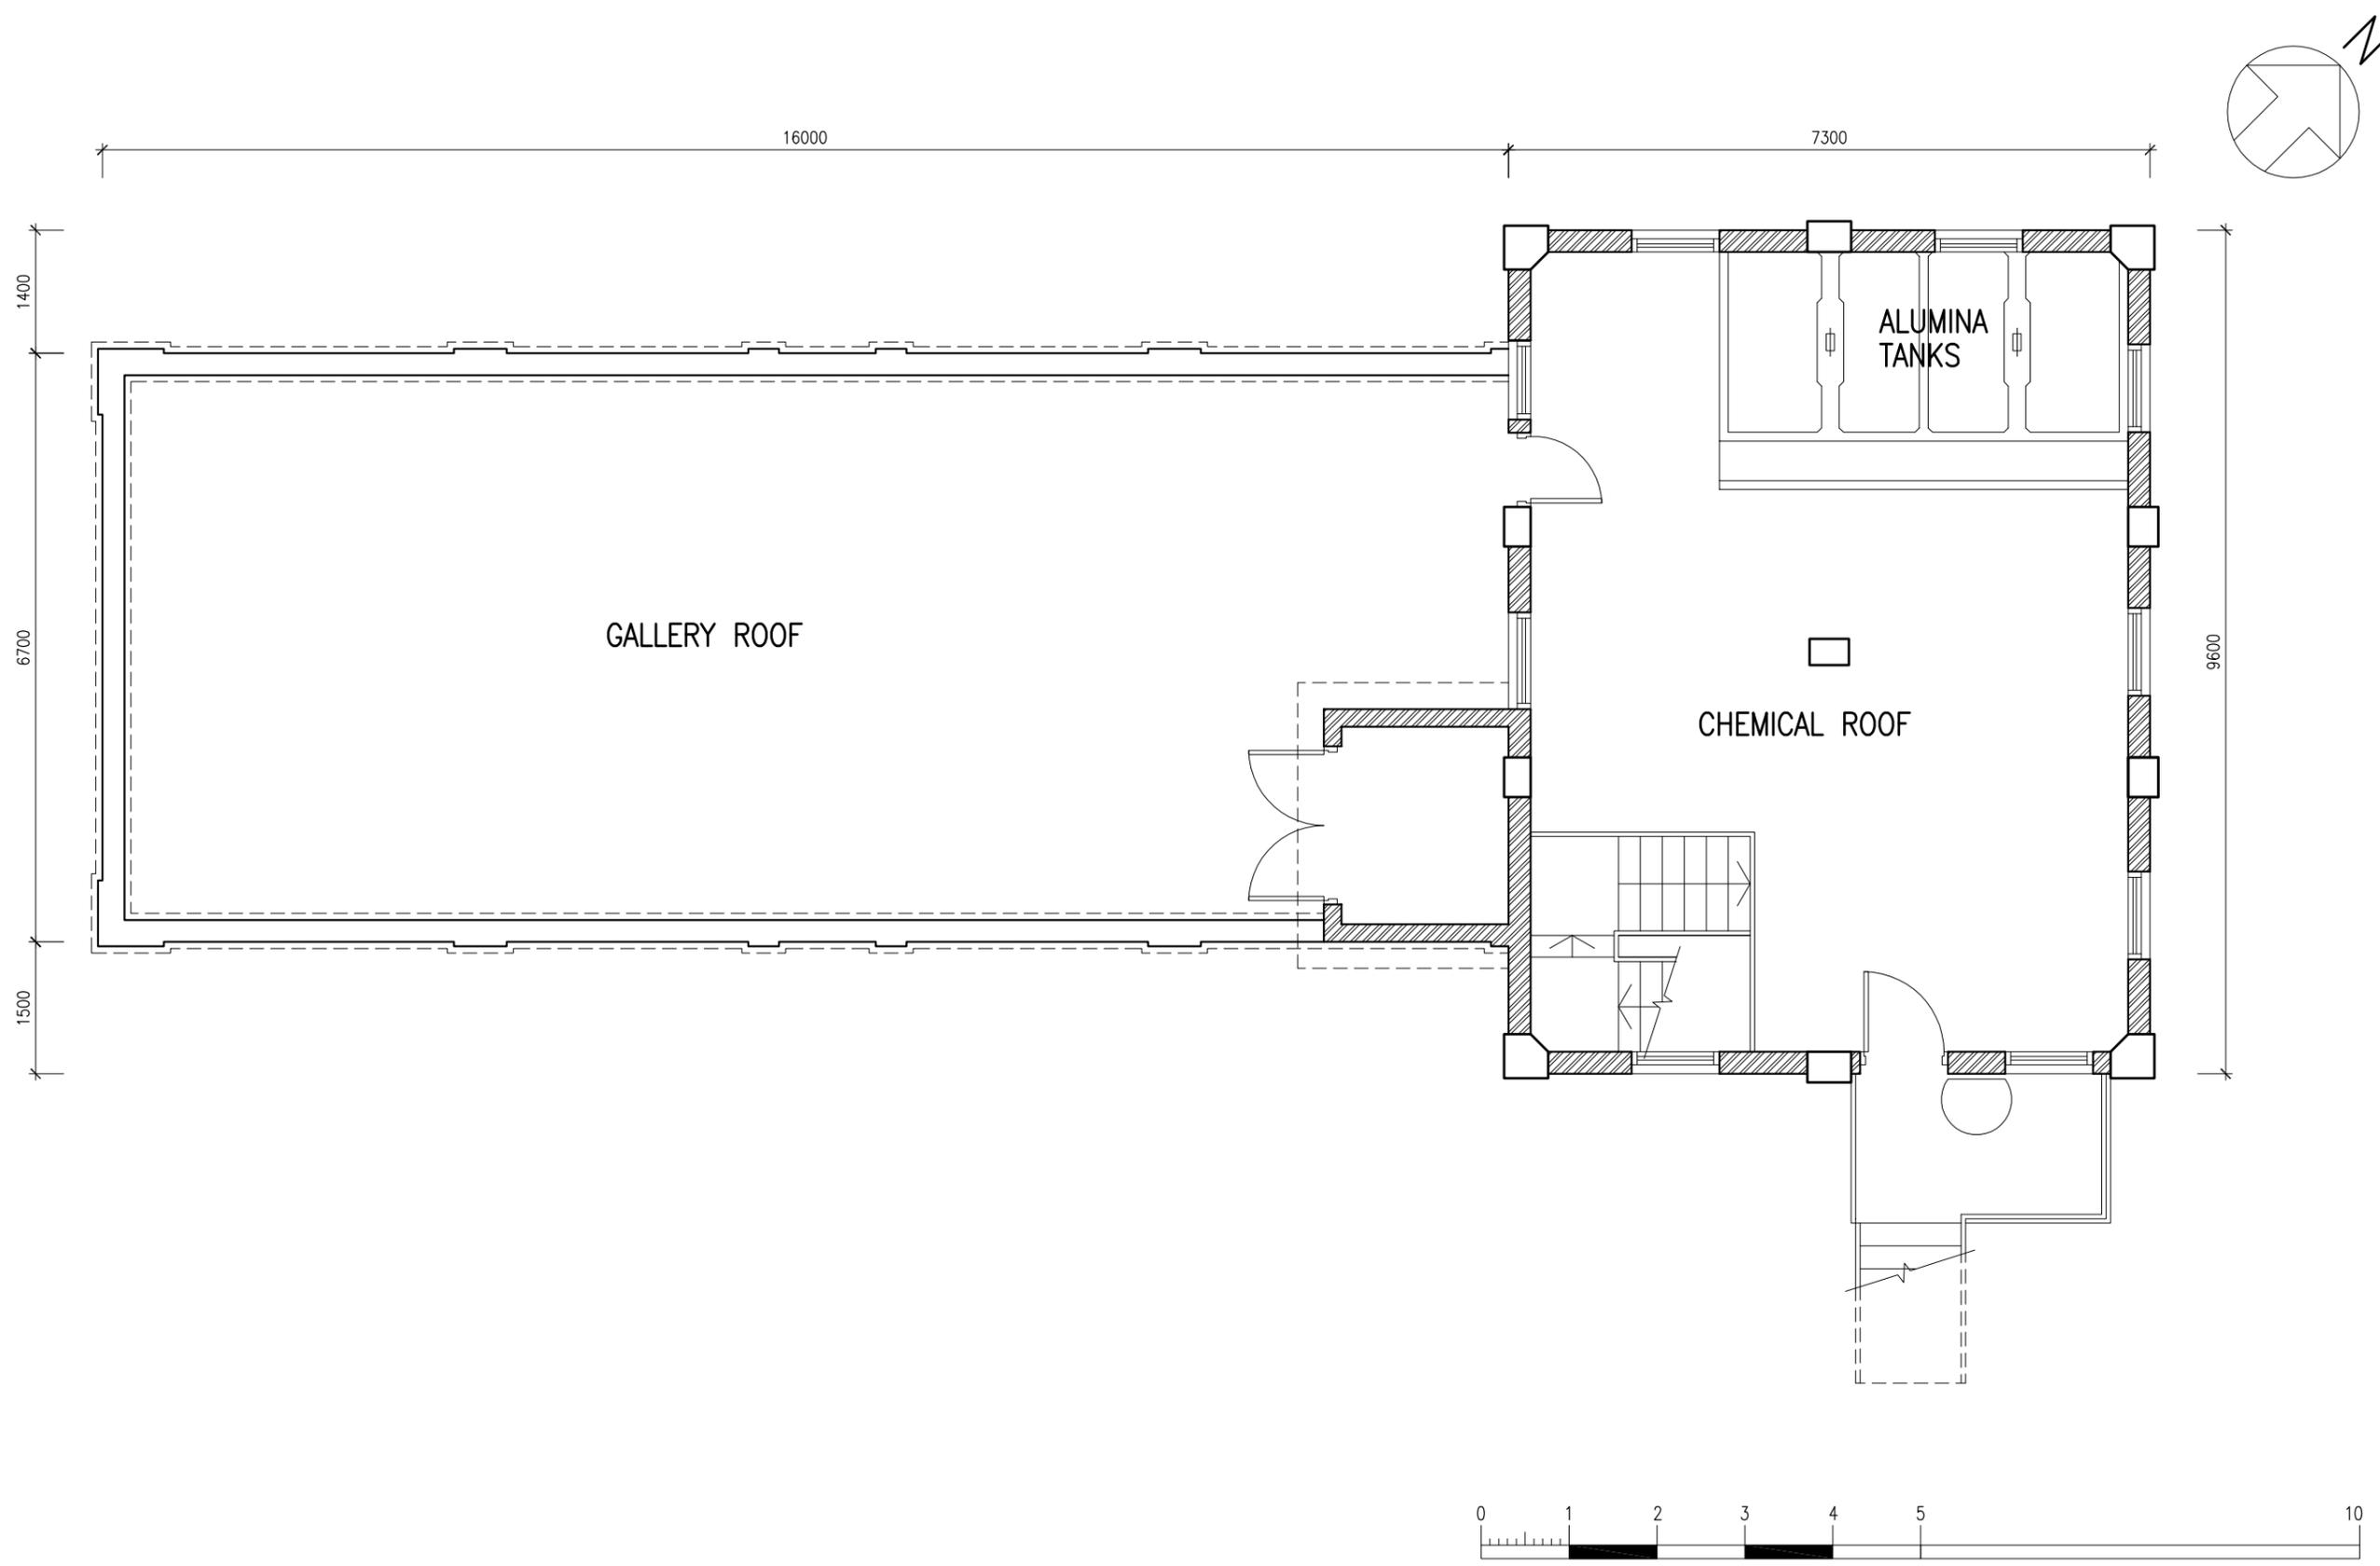
<p>Centennial Campus, The University Of Hong Kong</p>	<p>Elliot Pumping Station and Filters Treatment Works Building Upper Level Plan</p>	Scale	1 : 75 (A3 size drawing)
		Drawing No.	TWB-03
		Date	21 September,2008

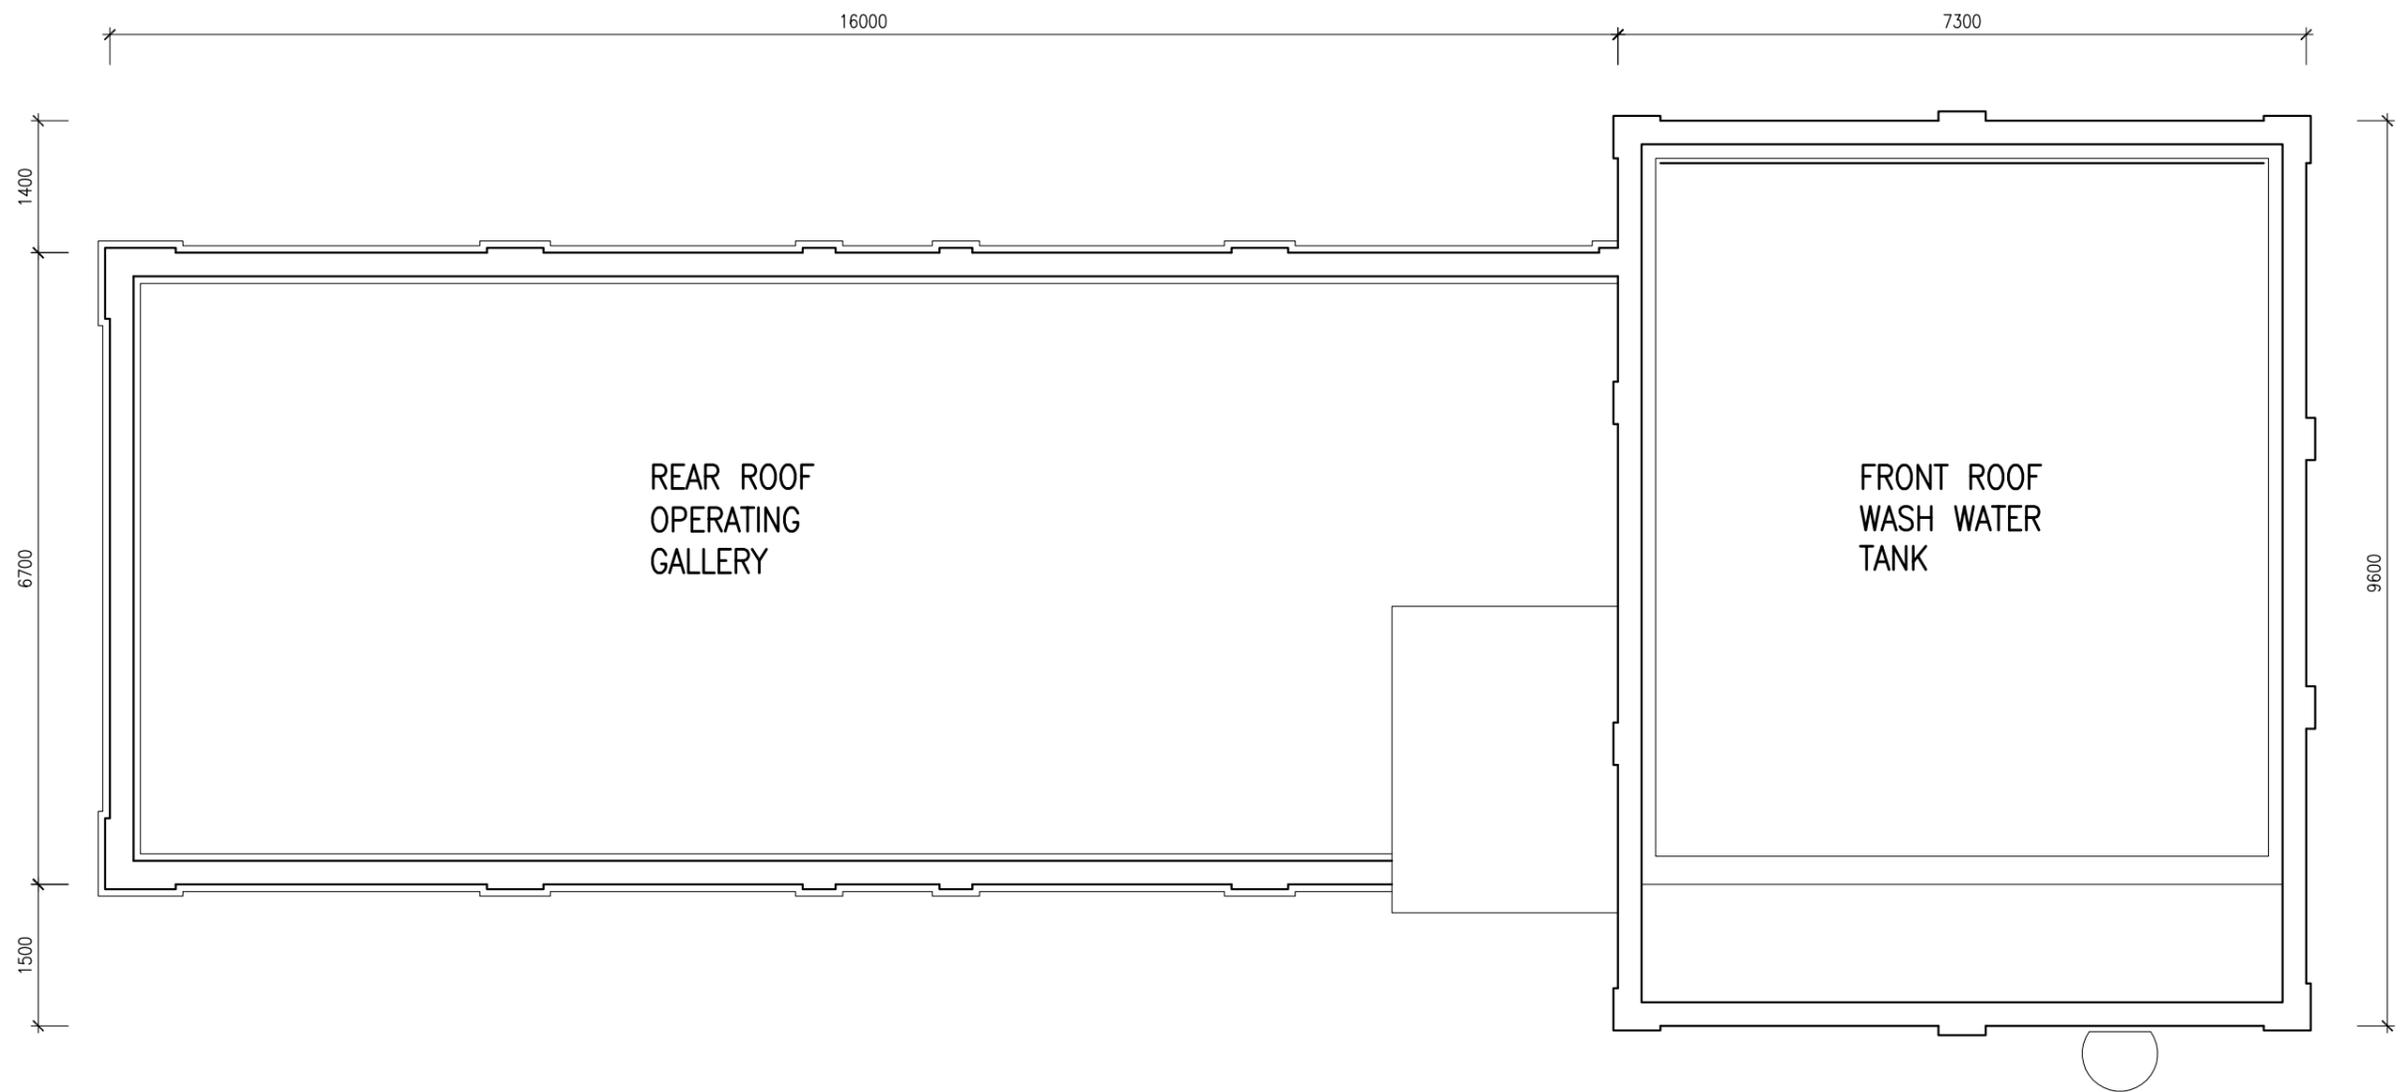
<p>Centennial Campus, The University Of Hong Kong</p>	<p>Elliot Pumping Station and Filters Treatment Works Building Roof Plan</p>	Scale	1 : 75 (A3 size drawing)
		Drawing No.	TWB-04
		Date	21 September,2008

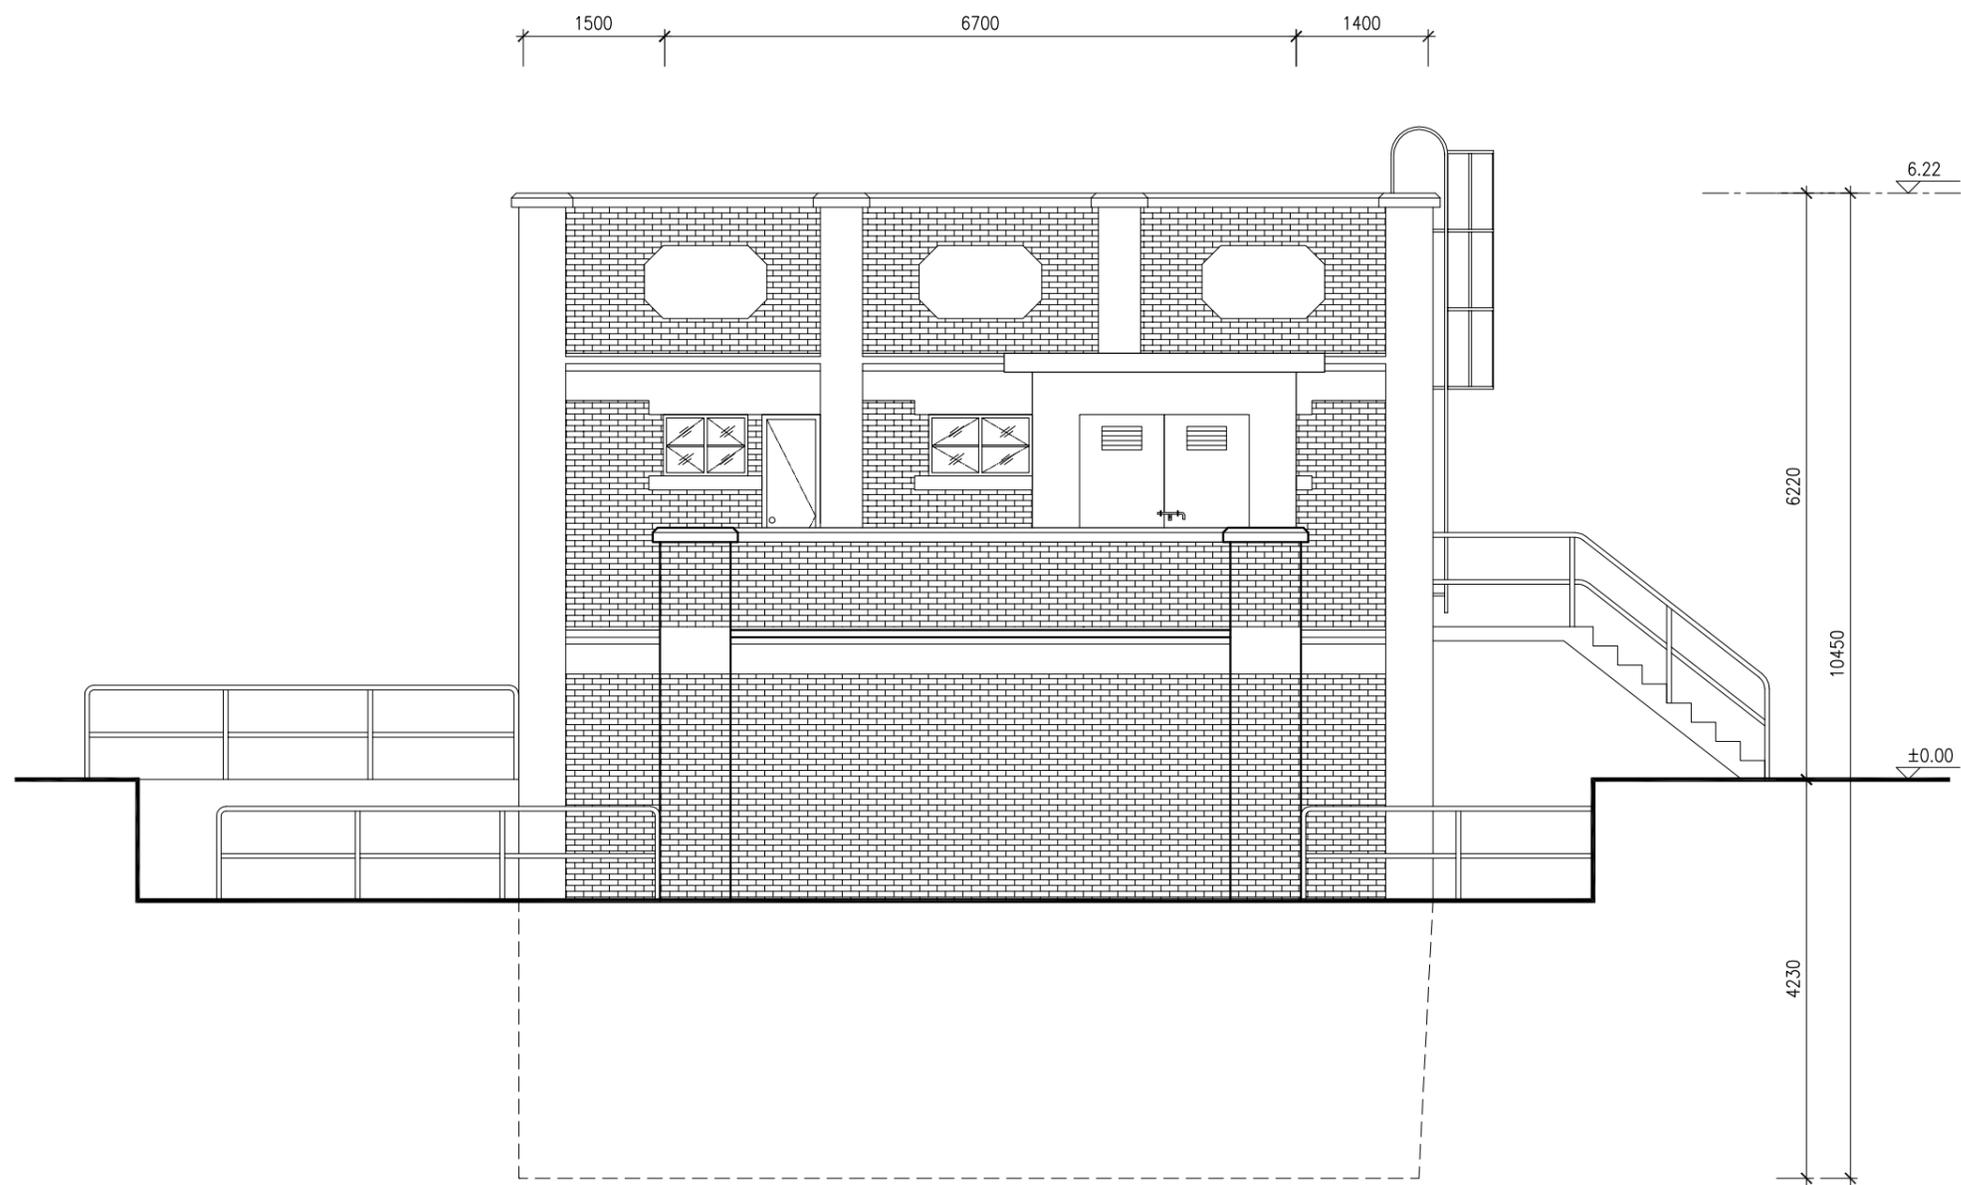
Centennial Campus, The University Of Hong Kong	Elliot Pumping Station and Filters Treatment Works Building South(front) Elevation	Scale	1 : 75 (A3 size drawing)
		Drawing No.	TWB-05
		Date	21 September,2008

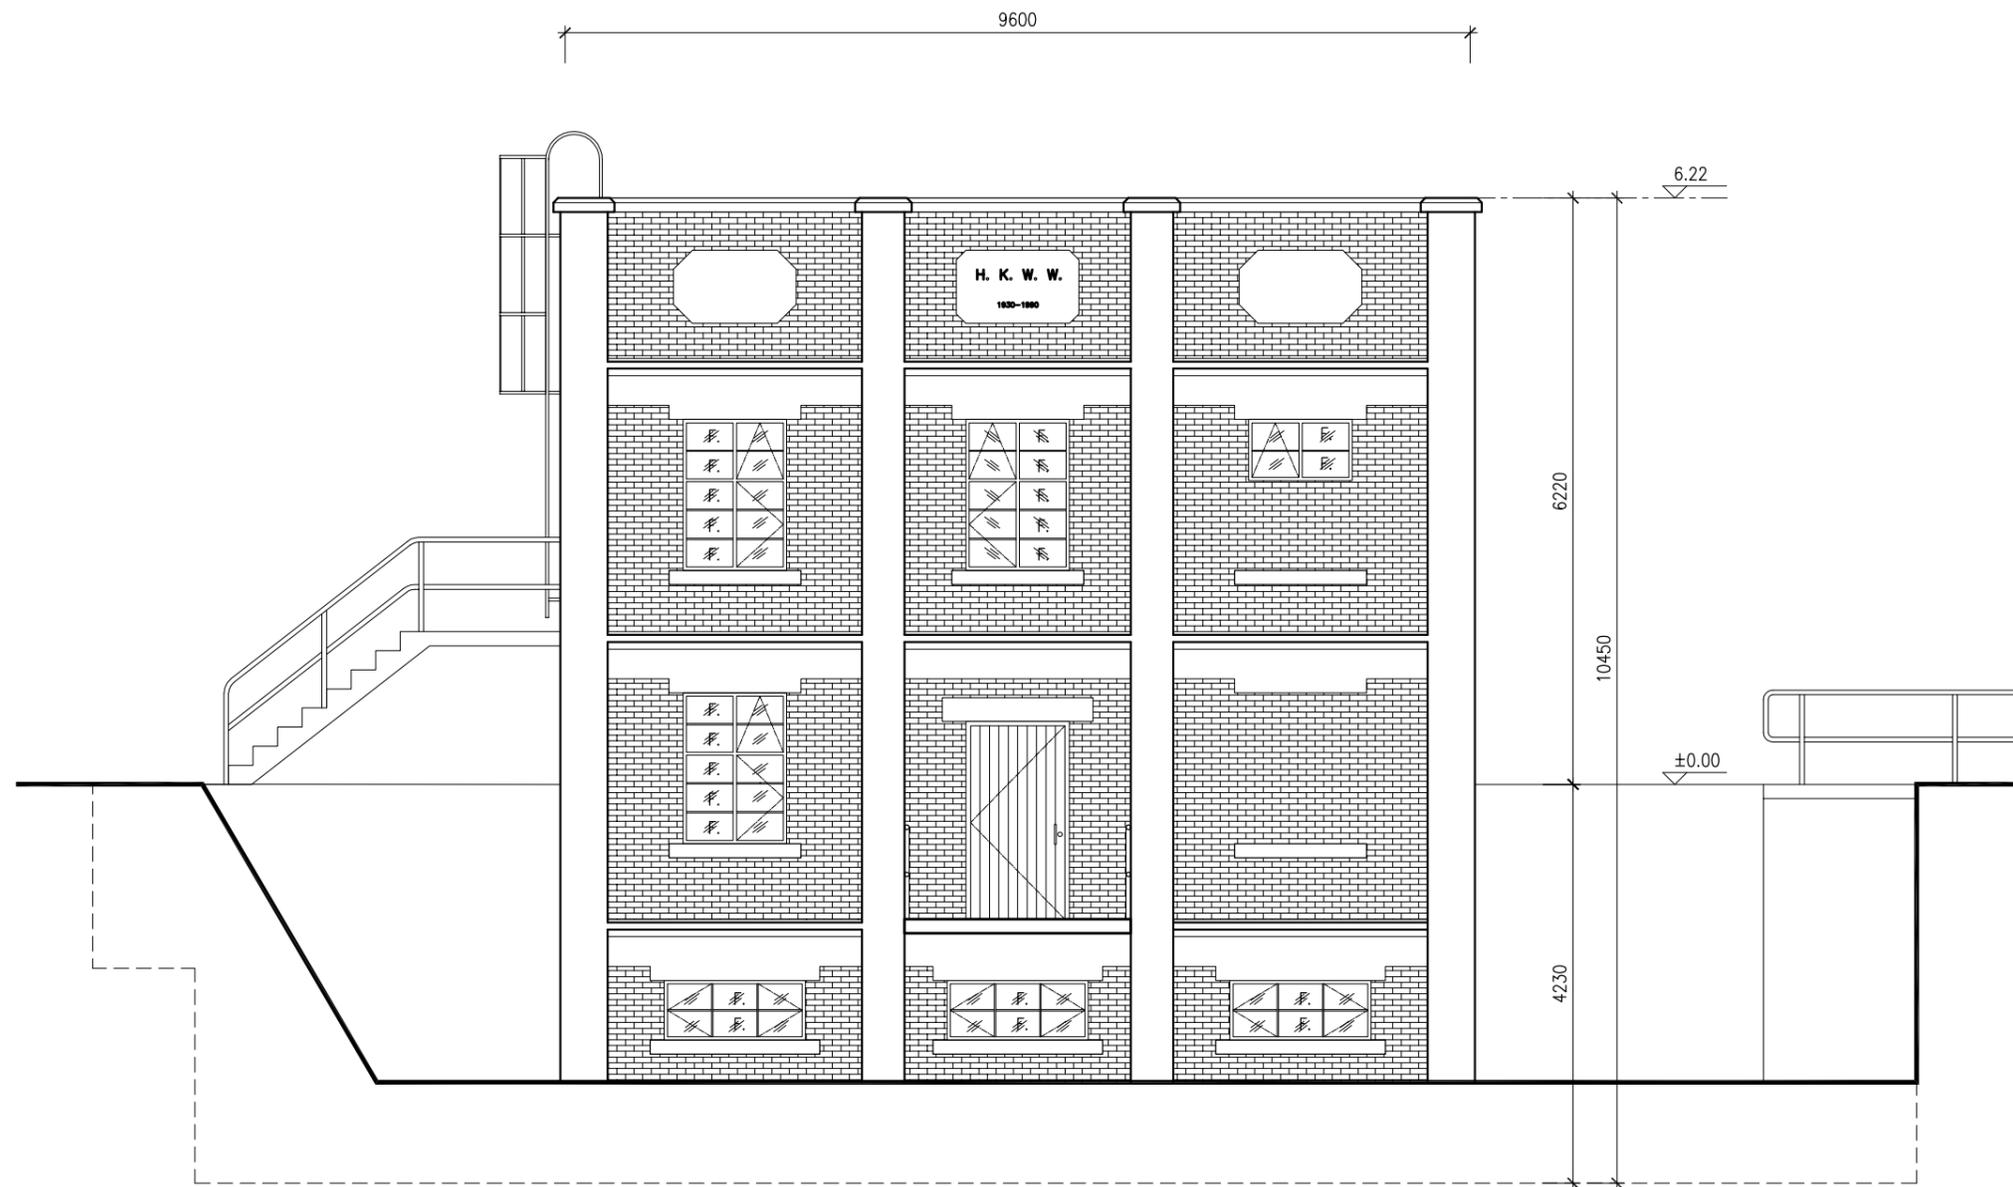
Scale	1 : 75 (A3 size drawing)
Drawing No.	TWB-06
Date	21 September,2008

Elliot Pumping Station and Filters
Treatment Works Building
North (rear) Elevation

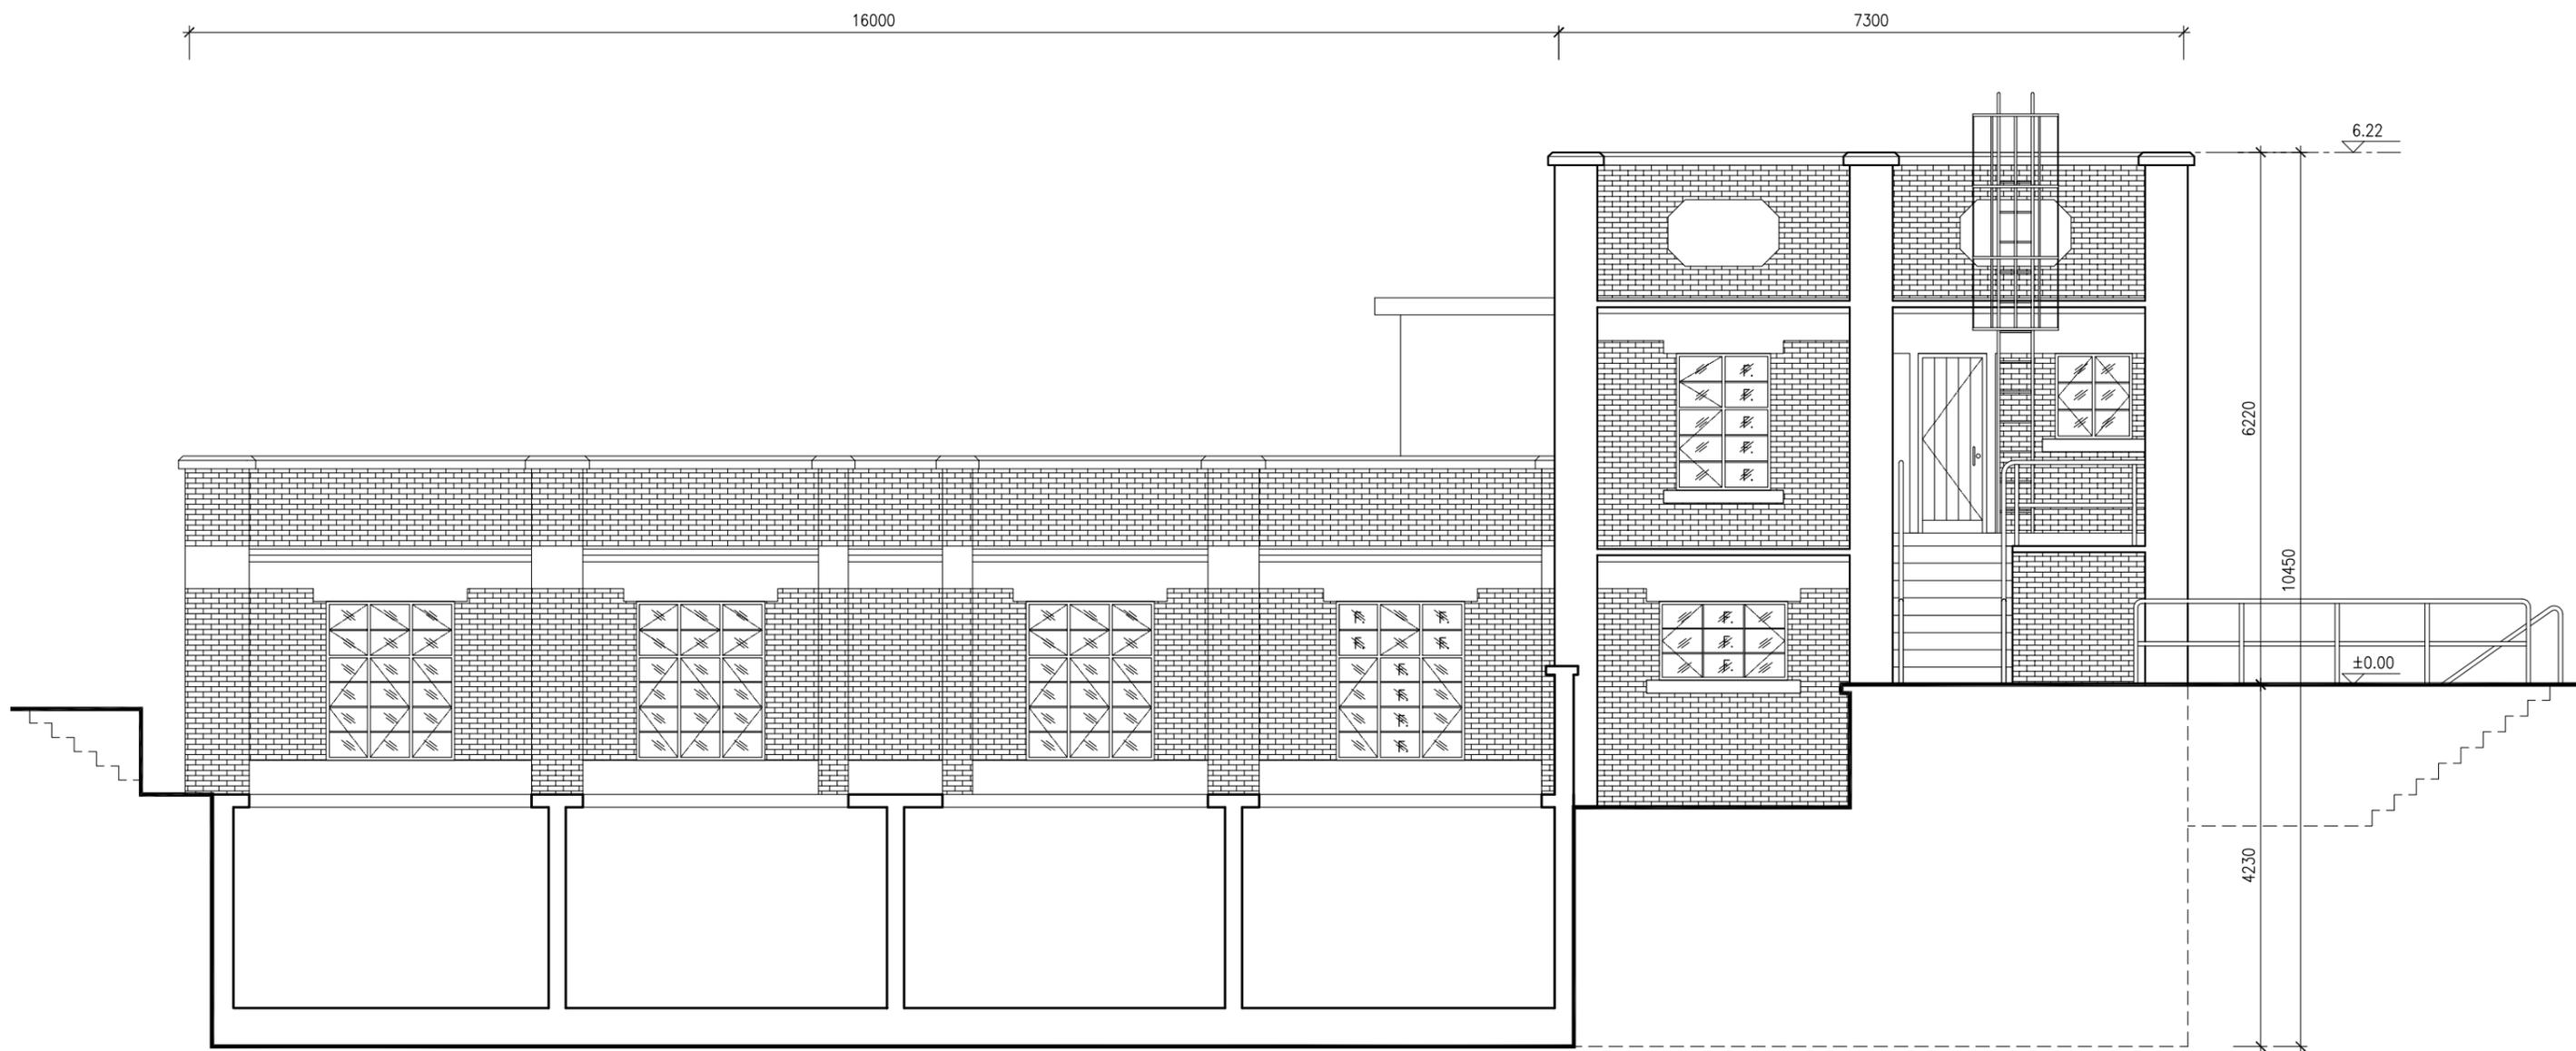
Centennial Campus, The University Of Hong Kong	Elliot Pumping Station and Filters Treatment Works Building East Elevation	Scale	1 : 75 (A3 size drawing)
		Drawing No.	TWB-07
		Date	21 September,2008

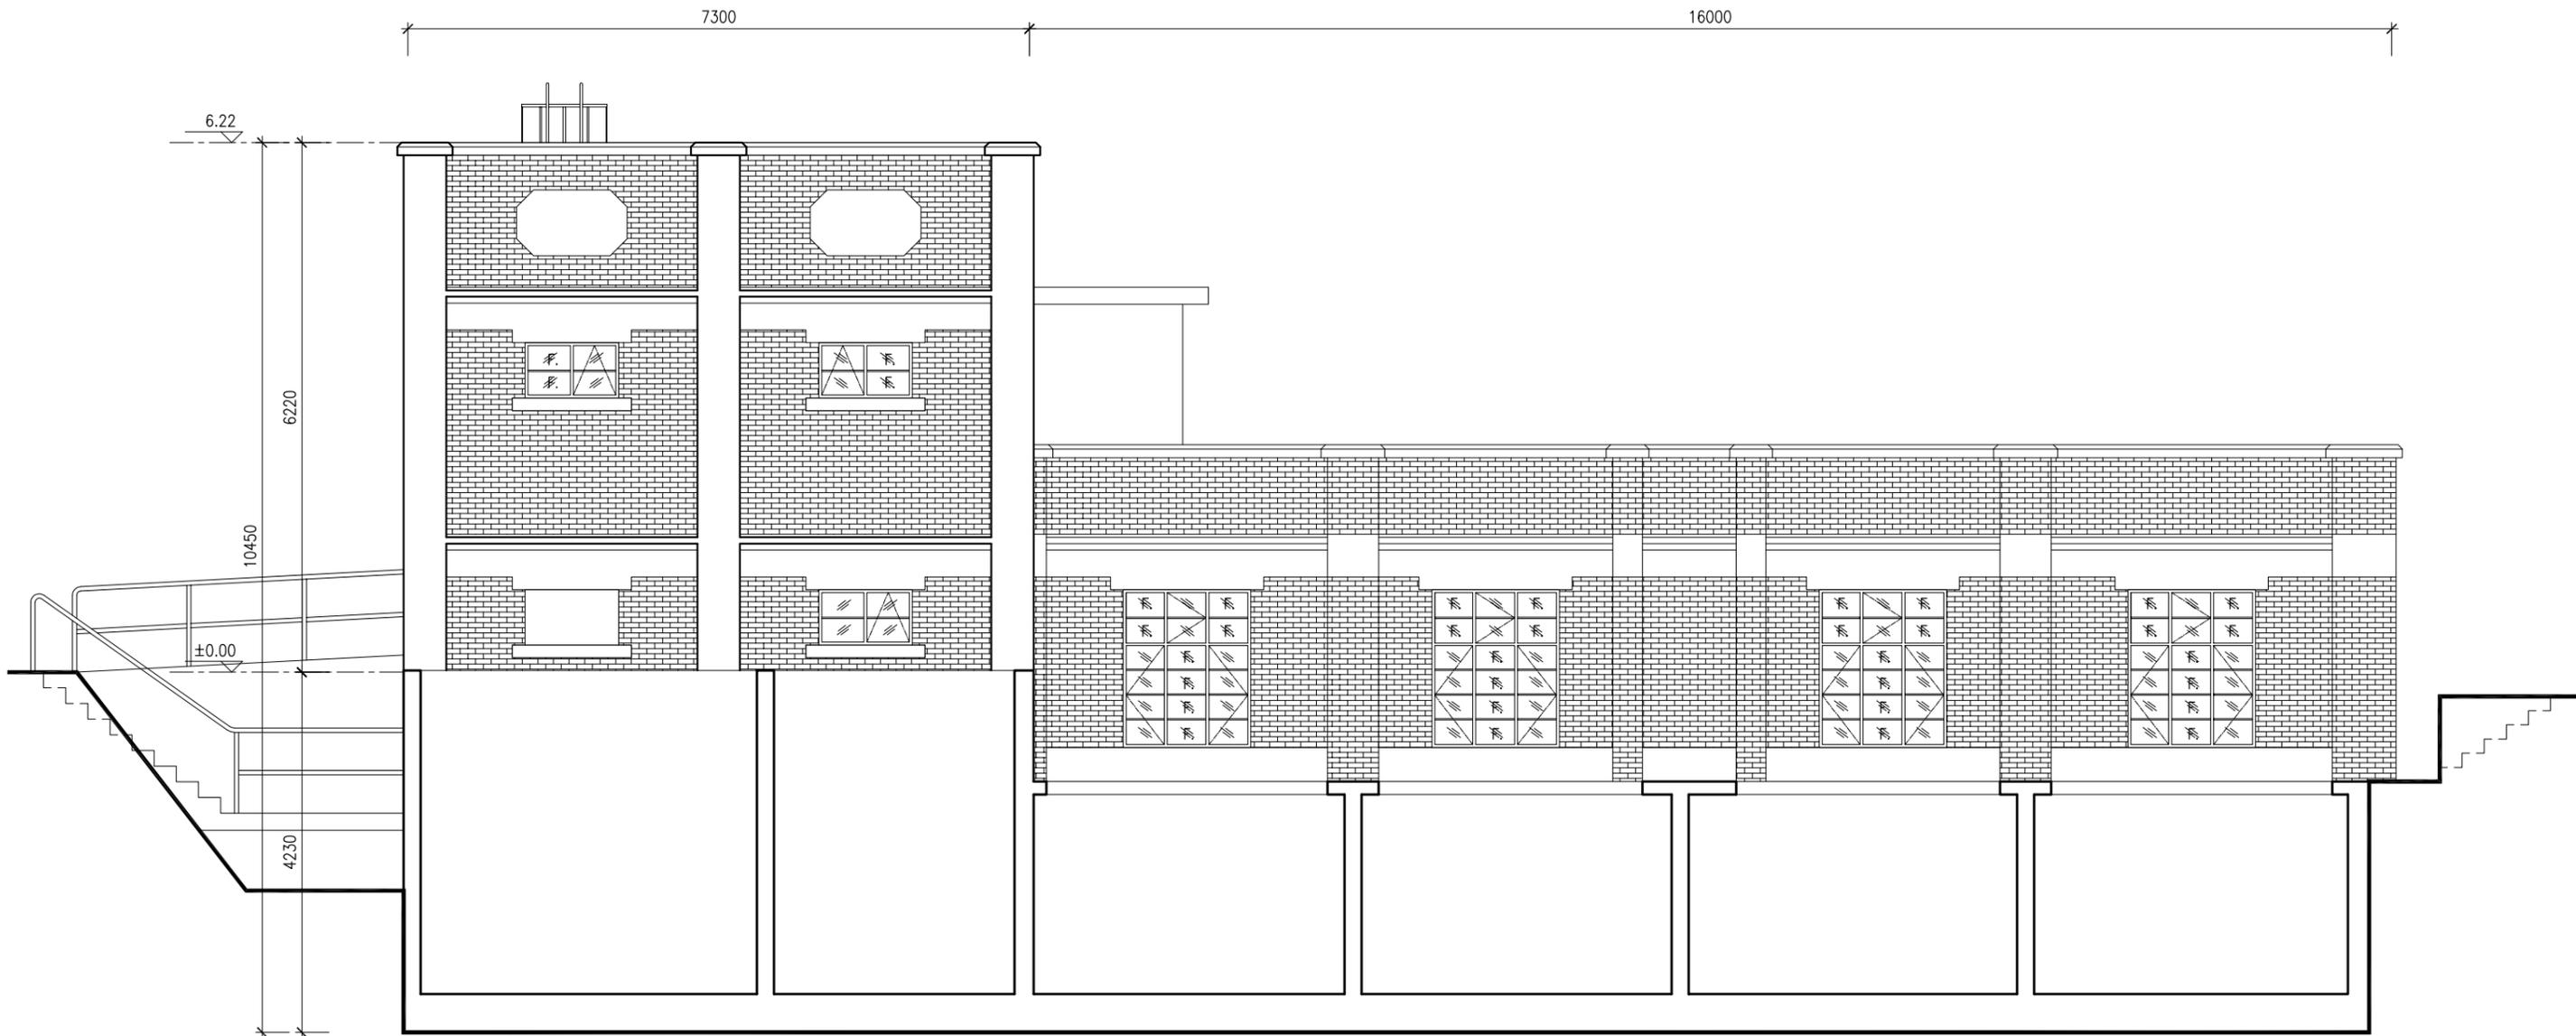
Centennial Campus, The University Of Hong Kong	Elliot Pumping Station and Filters Treatment Works Building West Elevation	Scale	1 : 75 (A3 size drawing)
		Drawing No.	TWB-08
		Date	21 September,2008
